Investigation and Analysis of an Explosion in a Research Laboratory at a French University

André Laurent^{*a,b}, Laurent Perrin^{a,b}, Olivier Dufaud^{a, b}

The accident occurred on March 24th, 2006 at 0:24 pm in a research laboratory building of the National Institution of Higher Learning in Chemistry of Mulhouse (ENSCMu) at University of Haute Alsace (France). Due to a leak from a gas cylinder, a violent explosion of ethylene took place in the enclosed laboratory space and was followed by a fire. The accident killed one professor, seriously injured a young trainee and injured 20 persons. The initial blast of the Vapour Cloud Explosion and the fire that burned for about 5 hours caused several major damages within the laboratory and the surrounding. The corresponding facilities were destroyed. Fragments were hurled up to 100 m. The sound of the shock wave was heard 10 km away. The estimated cost of the accident was about 25 M€.

The paper intends to summarize a detailed investigation report of the event. It points out the absence of hazard identification or risk analysis as a potential root cause factor, among others.

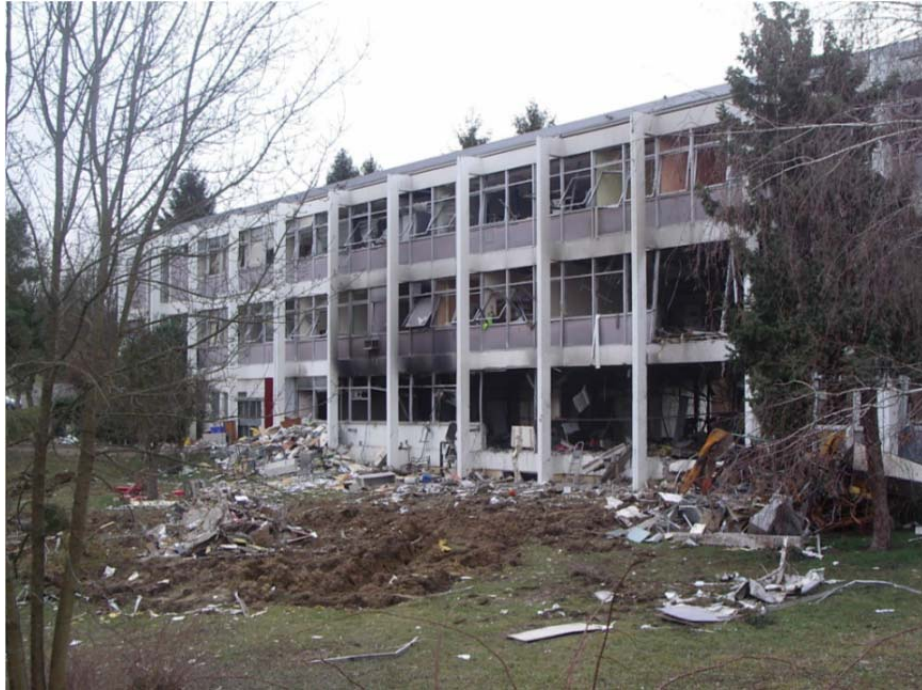
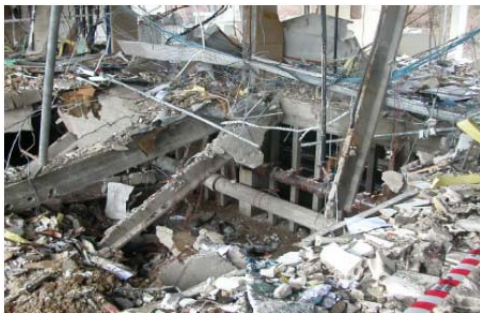
The explosion killed one professor in his office at the first floor, seriously injured a young trainee in an adjacent room and injured 20 persons. The initial blast and the subsequent fire which lasted about 5 h caused several major damages within the laboratory, the building No 5, the other opposite building No 2 and the surrounding. The blast blew out windows, ceilings and blackened walls. Fragments were hurled up to 100 m. The sound of the shock wave was heard 10 km away.

Figure 1: Selection of relevant photographs indicative of the damage on the building No 5 (front of the building – inside laboratory room – collapse of the floor).

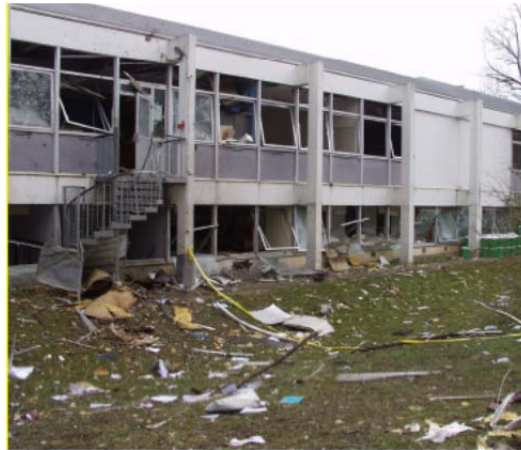
First an estimation of the overpressure was deduced from the analysis of the damage on the structures. Observed damages were compared to the database of typical damages related to overpressure levels. An interval of overpressures was then determined. No consideration is given to the details of elements fixings and ruptures. For example, Figure 2 shows the overpressure damages observed on the façade of the building No 2 located at 50 m in front of the building No 5, source of the explosion. The correlated values of the overpressure are in the range of 20 to 50 mbar (window glass cracks – warped frames, some of them ruptured). This estimation may not be very accurate, but it gives a good order of magnitude.

Figure 2 – Example of overpressure damages in the building No 2 located at 50 m in the front of the building No 5, source of the explosion (Neunlist, 2007).
