Investigation and Analysis of an Explosion in a Research Laboratory at a French University

The accident occurred on March 24th, 2006 at 0:24 pm in a research laboratory building of the National Institution of Higher Learning in Chemistry of Mulhouse (ENSCMu) at University of Haute Alsace (France). Due to a leak from a gas cylinder, a violent explosion of ethylene took place in the enclosed laboratory space and was followed by a fire. The accident killed one professor, seriously injured a young trainee and injured 20 persons. The initial blast of the Vapour Cloud Explosion and the fire that burned for about 5 hours caused several major damages within the laboratory and the surrounding. The corresponding facilities were destroyed. Fragments were hurled up to 100 m. The sound of the shock wave was heard 10 km away. The estimated cost of the accident was about 25 M€.

The paper intends to summarize a detailed investigation report of the event. It points out the absence of hazard identification or risk analysis as a potential root cause factor, among others.

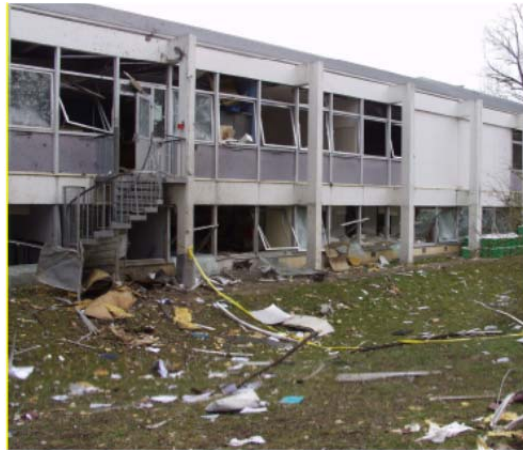
Figure 2 – Example of overpressure damages in the building No 2 located at 50 m in the front of the building No 5, source of the explosion (Neunlist, 2007).

First an estimation of the overpressure was deduced from the analysis of the damage on the structures. Observed damages were compared to the database of typical damages related to overpressure levels. An interval of overpressures was then determined. No consideration is given to the details of elements fixings and ruptures. For example, Figure 2 shows the overpressure damages observed on the façade of the building No 2 located at 50 m in front of the building No 5, source of the explosion. The correlated values of the overpressure are in the range of 20 to 50 mbar (window glass cracks – warped frames, some of them ruptured). This estimation may not be very accurate, but it gives a good order of magnitude.
