# A historical study of Chambord castle: A basis for establishing the health record of the monument

## **Abstract:**

**Keywords:** Chambord castle; historical data; limestone; tuffeau; degradation; restoration

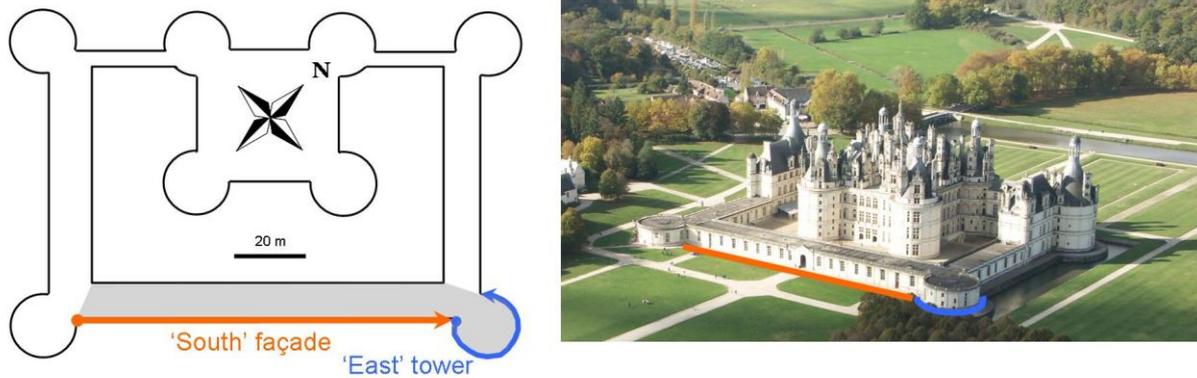
Fig. 1: The low surrounding building with the south façade and the east tower of Chambord castle

This paper aims to describe the history of stones used in the construction of Chambord castle mainly two sections dating from the first part of the 16<sup>th</sup> century: the south façade and the east tower (figure 1). The various type of degradations are then analysed considering the history of stones (implementation, restoration or replacement) and their location on the monument. The tower is located at the east of the castle, but the studied façade, is directed to the southeast, and commonly called "south façade". This façade, is the main entrance of the castle, was often modified by the various kings and owners, and often restored. The south façade is interesting to study because dates and provenances of replacements are various. The east tower was less valued and little restored. The stones of the tower are original, highly degraded and so of a great interest to this study, which aims to link types of stones, ages of stones and state of degradation and orientations and climatic conditions.

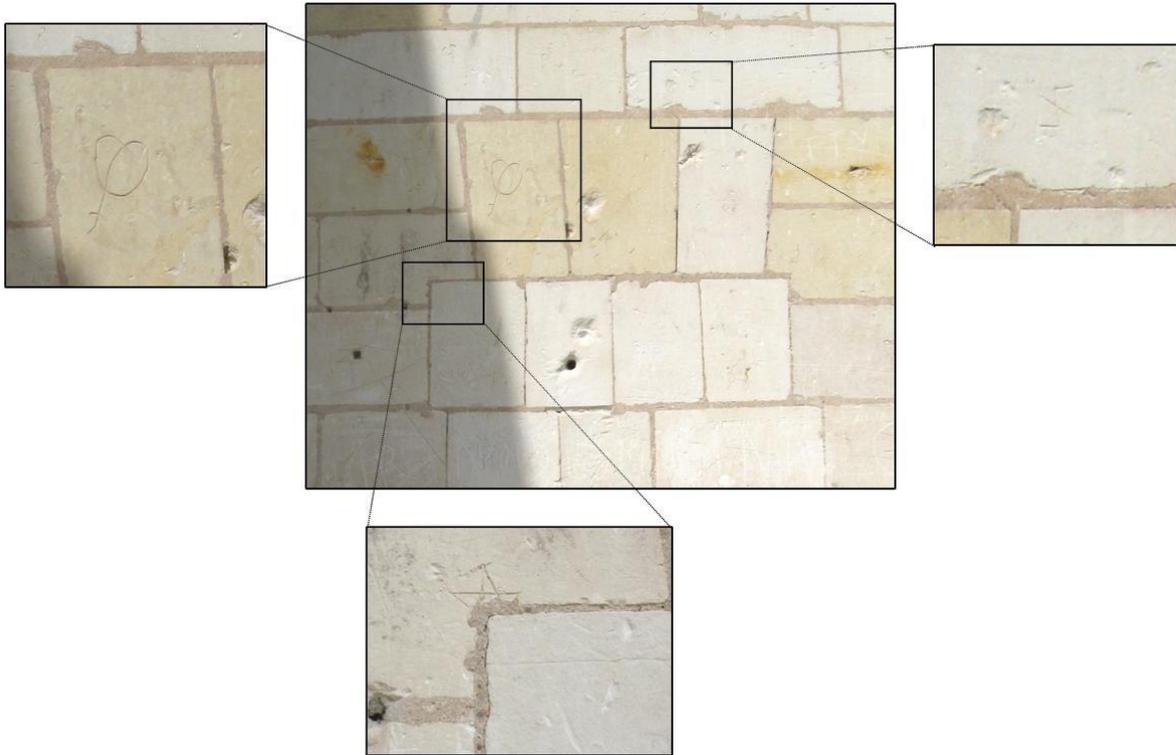
Fig. 2: South façade: door walled on the first left span, with a lapidary sign cut by the addition of a stone to the wall above the door, probably before 1555

Archaeology also provides important data. Many stones in Chambord castle show lapidary signs (Fig. 2). Often, each stone cutter engraved his own distinctive sign into the stones he sculpted. For plain vertical walls, workers were paid by the “toise” (area), or by the day. For carved sections (such as cornices, pilasters, mouldings and capitals), they were paid according to the task (e.g. the number of sculptures). On all these value added stones, lapidary signs were observed (Châtenet, 2001). These marks give guidance regarding the chronology of the works and the organisation of the construction process. They also allow us to identify stones dating from earlier stages of the building process. For the identification of the generic stone used in the façades, in addition to lapidary signs, archives provide important information, although it is sometimes incomplete.

Stones including lapidary signs on the south façade probably date back from the first stages of construction. Moreover, during the final phases of construction (between 1540 and 1545), interior transformations took place in the south façade (Bryant *et al.*, 2007), perhaps leading to the walling of nine small doors, which are still visible in front and detectable by their lintels (Fig. 2).

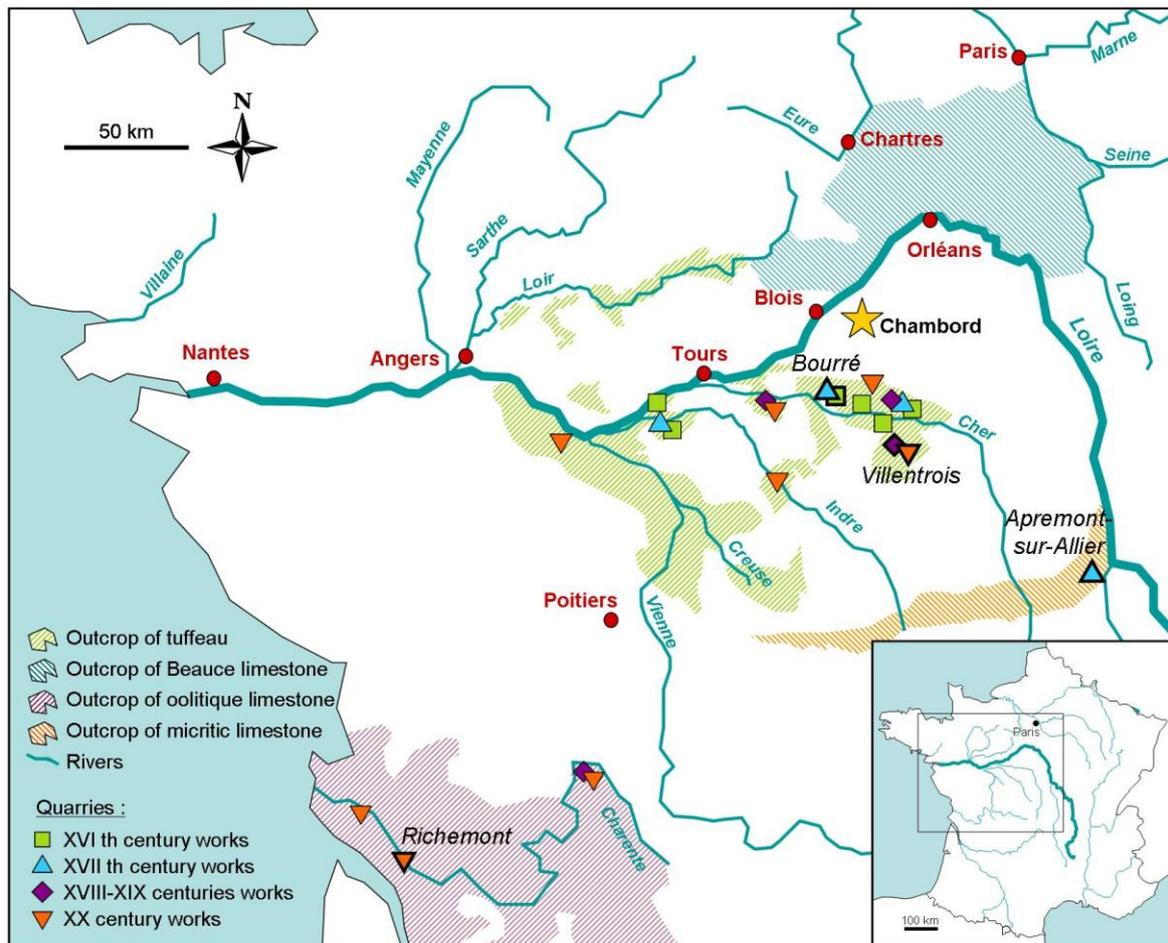
Fig. 3: Simplified map of the location of quarries used to the construction of the castle of Chambord (from Mussat, 1991; Rautureau, 2001; Yvard, 1976; Gorget, 1990)

Historically, tuffeau material is used for the construction of Chambord, due to its geographical proximity. The tuffeau of Bourré (see location in Fig. 3) is the dominant stone in the castle, in 16<sup>th</sup> century works. Texts say that tuffeau limestone used during the reign of François I for the construction came from six different quarries and were used to an equal extent without attention being paid to their strengths or physical characteristics (Penet, 1963).

Over the centuries, new tuffeau quarries are used as well as other harder limestones, more distant from the Loire. To replace tuffeau, oolitic limestone of Poitou-Charente has been much used from the 20th century (Fig. 3). So, in the early twentieth century, tuffeau quarries exploited are totally different from original tuffeau quarries. During the restoration of monuments, in the case of replacement stones, the question arises about the compatibility of these stones. Thus, in our example, for the South façade and the East tower, in the early twentieth century, the choice was to use only Richemont stone in substitution of tuffeau. At that time, many other tuffeau buildings were restored in Richemont stone, which is a white calcareous stone and considered more sustainable than tuffeau (Birginie, 2000; Dessandier, 2000). Richemont, limestone from quarries in Charente-Maritime, has the same geological age as tuffeau but with different properties from tuffeau (table 1). In the 90s, letters of architects and curators found in archives, show that considerations and guidelines of restoration are changing: Richmond stone is only used to make the transition between bases with hard limestone (Beauce limestone) and tuffeau facings. Finally, now, only Villentrois tuffeau is recommended by architects because it is considered similar to the original tuffeau: Bourré tuffeau<sup>5</sup>, very white tuffeaux, with fine grains (table 1), Quarries of Bourré no longer exist but the extraction of Villentrois tuffeau is near the old quarries of Bourré (Fig. 3).

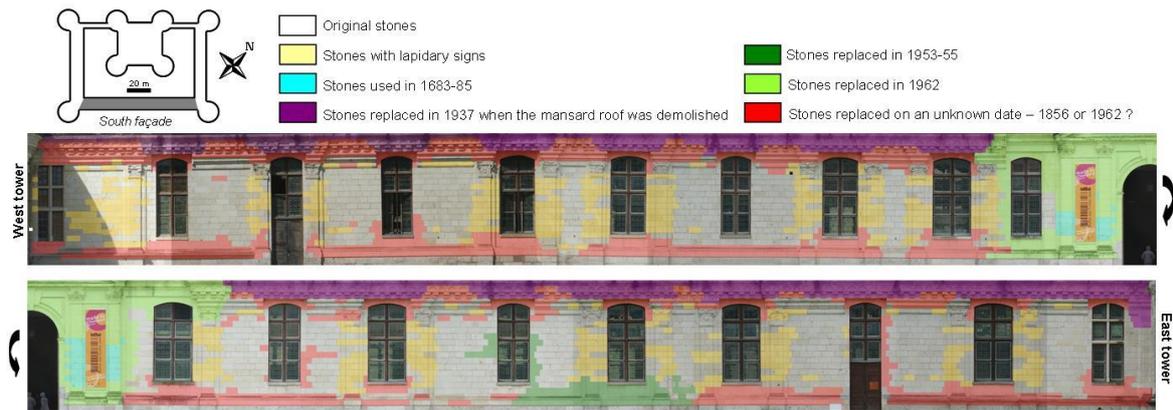
Based on lapidary signs, various stones from the south façade can be considered to be original, according to their dating (Fig. 4). In fact, from 1683, under Louis XIV, the Royal Portal and the adjacent span were completely rebuilt<sup>6</sup>. Also during this time, the southern parts of the castle, which were originally covered with terraces, were covered with a mansard roof (Paquet, 1937), windows were enlarged and parts above the windows were cut<sup>7</sup>. In this case, restoration seems to have involved cutting the existing stones, rather than replacing them. In 1937, a mansard roof was demolished and the cornices were restored. Stones were added above the windows in order to restore them to their original form. For these restorations, texts mentioned the use of "Salamander stones" from quarries of Saint-Même, in Charente. This stone has similar characteristics to those of Richemont stone, whose quarries are near (Fig. 3). This upper parts of the façade have been restored in 1856 or 1962 (sources are incomplete and we can not be sure)<sup>8</sup>.

In 1953, when the castle began to become a tourist destination, the reception desk was constructed. Stones under and around certain windows, on the right hand side of the south façade, were replaced on this occasion with Richemont limestone<sup>9</sup>. Finally, in 1962, the Royal Portal, which was badly damaged after the Second World War, was completely rebuilt, also with Richemont stone. The *stylobate* and numerous stones from the cornices also appear to have been restored with the same stones<sup>10</sup>. Quotations dating from 1856, and others dating from 1962, mention the replacement of these stones. However, the existence of quotations does not prove that the work was certainly done. Finally, since 1962, no more restorations have been carried out on the south façade.

Fig. 4: Distribution of various stone replacements on the south façade

The stones on the façades which have no colour code on the map can be considered as original stones (Fig. 4 and 5). The proportion of visible stones replaced during each period of restoration has been estimated using data from planar projection surfaces. These estimations cannot provide information regarding the volume of stones used. Moreover, these data should be treated with caution, as some dates for replacement may not be precise. However, this estimation gives the percentage of original visible stones (16<sup>th</sup> century), compared to the percentage of stones replaced later on. It indicates that nearly 50% of stones on the south façade have been replaced. This proportion differs from the east tower, where 80% of the stones are original. As the main entrance for public visitors to the castle is in the south façade, this façade has therefore been largely restored over the centuries, unlike the east tower, which is further back and away from tourist traffic. Moreover, the east tower has degraded to a greater extent than the south façade due to its location, as it overlooks the River Cosson, and is exposed to the wind.

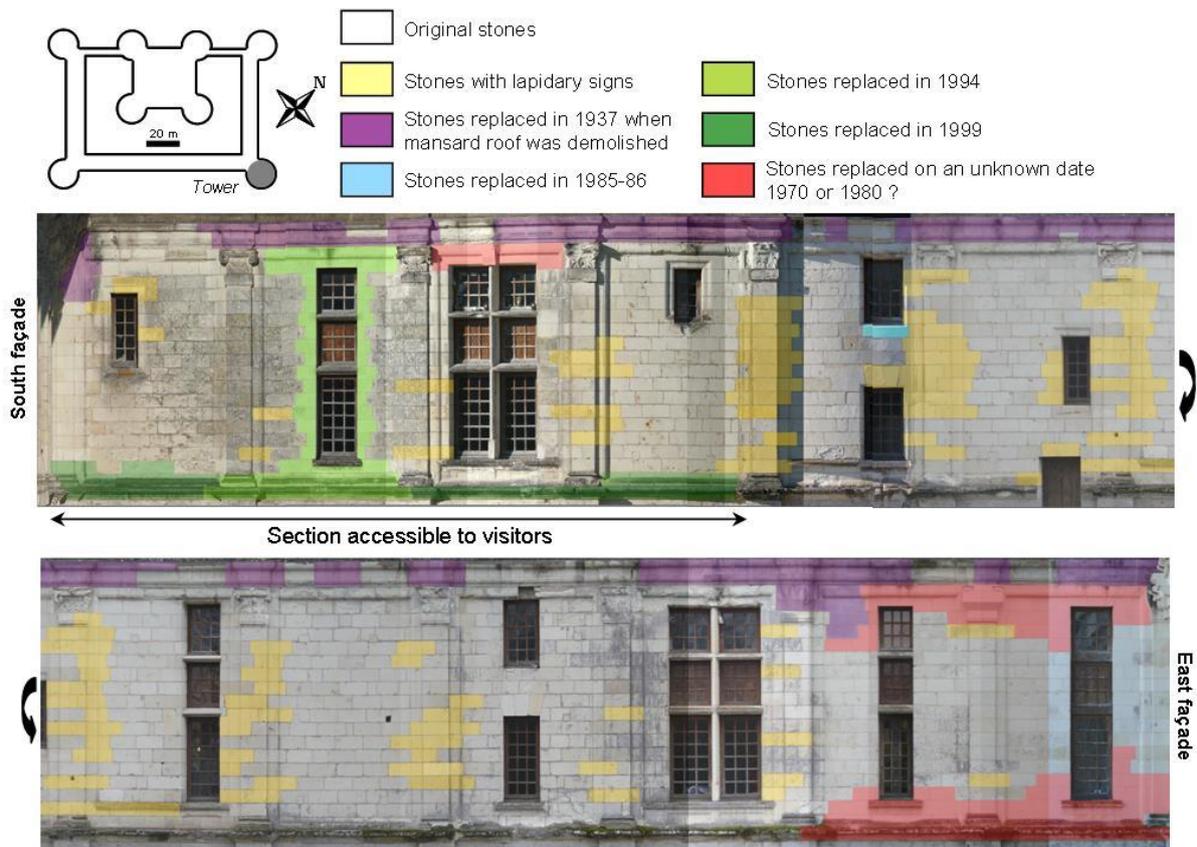
Unlike the south façade, the east tower underwent only a few rearrangements (Fig. 5). As for the south façade, stones with lapidary signs can be considered to date from the early phases of construction. The first mentions in the reports of stones being replaced date from 1937, when the floor under a mansard roof which had been established on all of the low surrounding buildings was destroyed and replaced by the original terraces. At that time, the upper parts of the tower were restored using salamander stones<sup>11</sup>. Thereafter, guidelines of architects are to use stones close to the original: the Villentrois tuffeau is chosen. This tuffeau was used to make the fifth window from the left of the tower, it can be reliably dated from 1986<sup>12</sup>. The *stylobate* stones in the first four spans of the tower, which are accessible to the public, were replaced between 1994<sup>13</sup> and 1999<sup>14</sup> with Richemont limestone and tuffeau from Villentrois. Spans not accessible to visitors are non restored for financial reasons. Window frame no. 2 was also replaced with tuffeau. Finally, on the last spans of the frieze, adjacent to the eastern façade, some new stones were added, which were probably Villentrois stones. The dates at which they were replaced can be estimated as being between 1970 and 1980<sup>15</sup>. This mapping shows that the stones were mainly replaced in the upper parts. These parts were the most degraded because they are in relief, and therefore stones are more exposed. The salient *stylobate*, now very impaired, was previously partially restored. Probably, during the next restoration of the east tower, the *stylobate* will be restored first.

Fig. 5: Distribution of various stones replacements in façades of the east tower

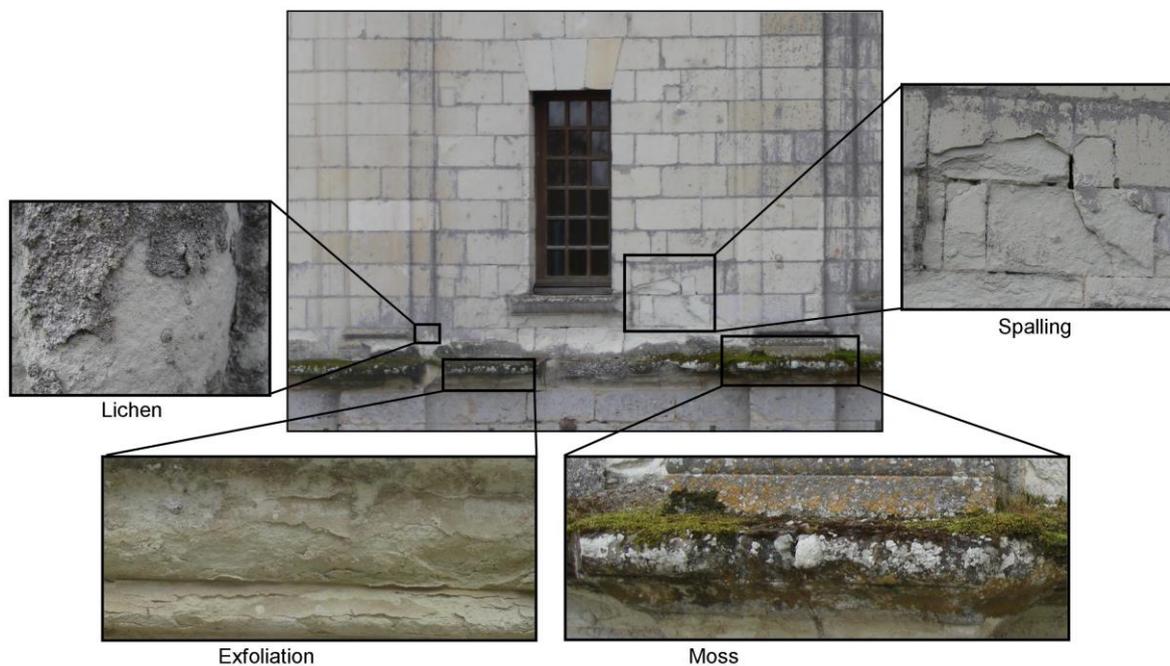
The detachment of stones with different thicknesses resulting in spalling or exfoliation can also be observed in the figure 6. Spalling is the most common form of degradation in the case of tuffeau, and the most damaging. It concerns carved stones, but also vertical facings, often initiated by reliefs (pilaster, windows). Over time, a plaque (one to three centimetres thicknesses) gradually forms on the surface of stone, and peels. The resulting stone surface turns into powder. The physico-chemical mechanism behind the formation of such plaque is still unclear, and many hypotheses have been advanced (Philippon, 1992; Dessandier, 1995; Imbault-Brunet, 1999; Rautureau, 2001; Thomachot, 2002; Beck, 2006). Testing samples have been taken on damaged areas of the castle of Chambord. The result of mineralogical characterization reveals physico-chemical degradation with presence of gypsum content in the powder zone on both sides of the cracking zone. Exfoliation mainly occurs in carved stones, which have a high specific surface area and thus a greater surface for evaporation. They also affect the lower parts of *stylobate* or cornices, which are generally more sheltered from the rain, and thus from leaching (ICOMOS-ISCS, 2008). The analysis showed the presence of gypsum in the leaves of exfoliations. The process of formation of these alterations and the origin of gypsum (air pollution, restoration mortars...) is not yet defined.

Fig. 6: Different types of alterations observed at Chambord – Example of the north part of the east tower

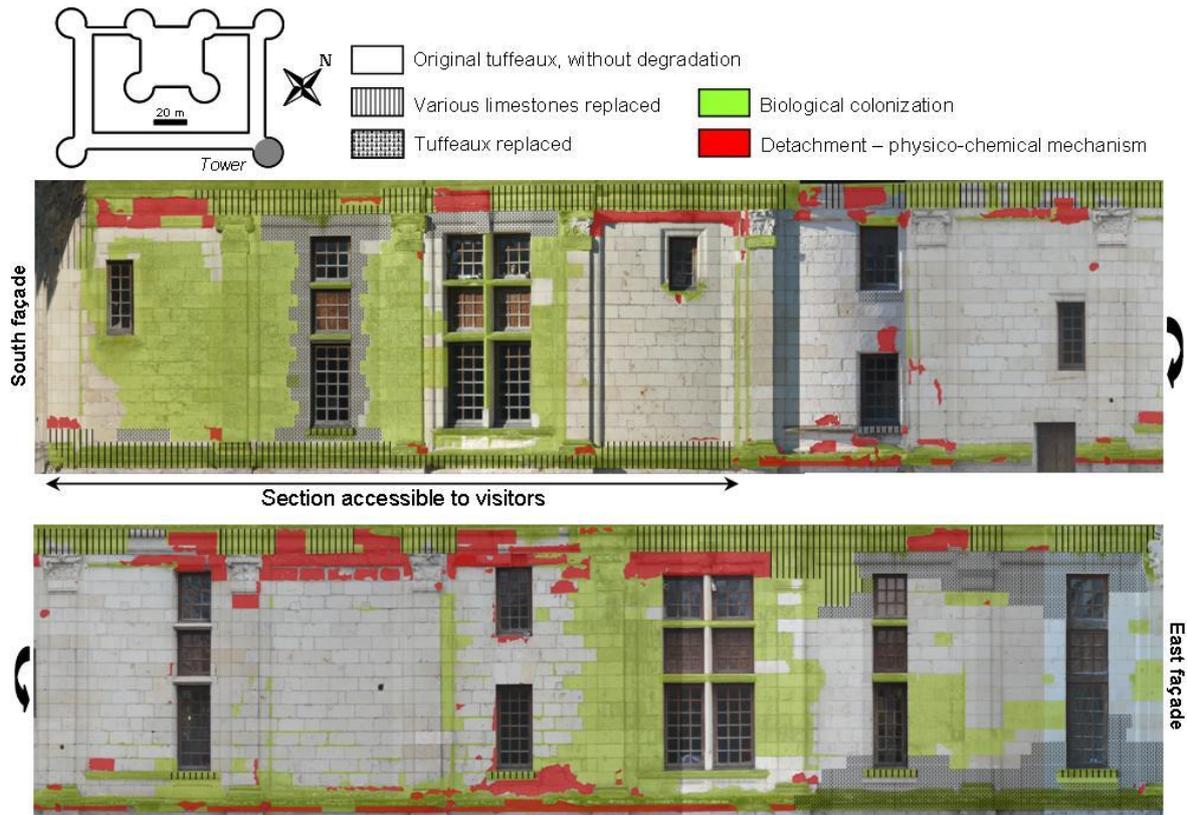
The east tower was less restored and more exposed to climatic variations than the south façade. So, the tower is more degraded. Figure 7 shows that physicochemical degradations affected the oldest tuffeau (red zone), but not yet stones replaced in the 20<sup>th</sup> century, tuffeau (squared zone) or Richemont stone (striped zone), because physicochemical degradations are a long process, conversely to biological degradations. Indeed, there is no observable relationship between biological alterations (green zone) and the age or provenance of the stone. The relief, the disposition and the orientation of the stones determine the location of biological alterations: a cornice with a horizontal relief is usually more covered with moss (because of water accumulation) than a vertical face (which dries quickly). So, vertical walls are colonized less rapidly than horizontal areas, as shown on the second bay of the tower.

Fig. 7: Age and decay features of stones in the east tower

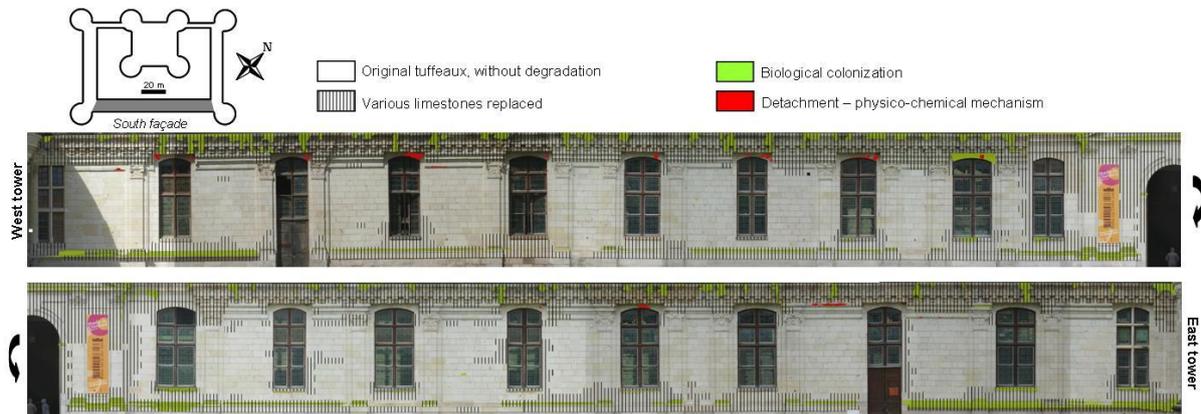
The mapping in figure 8 shows that the south façade is less degraded than the east tower. Spallings (red zone) are only located on ancient tuffeau. Concerning the degraded parts above the windows, doubt remains about their replacement date. If they had been restored in 1962, they would not be much degraded. They probably were restored in 1853, but we do not know if original tuffeaux was just re-cut on the surface or replaced with new tuffeau.

Fig. 8: Age and decay features of stones in the south façade

Visually, in the south façade, spalling are less developed than in the northern parts of the tower, probably because the south facade was restored very often, mostly with Richemont stone (striped zone). Compared to Tuffeau, Richemont stone is more resistant, less porous and so less sensitive to spalling. Moreover, physicochemical degradations are not observed on Richemont stone recently placed in the castle (less than 60 years ago) because it's well known that these types of decay are time dependent. Colonizations (green zone) are less present than on the tower, because of the orientation of the façade (very sunny, like the five center spans of the tower). The development of micro-organisms and then, lichens and mosses, is difficult and slow on a dried wall. But the areas with relief have sometimes biological degradation, because they retain moisture (green zone with superimposition of striped zone).
