Historical Study of Chambord Castle: Basis for Establishing the Monument Health Record

A historical study of Chambord castle: A basis for establishing the health record of the monument

Keywords: Chambord castle; historical data; limestone; tuffeau; degradation; restoration

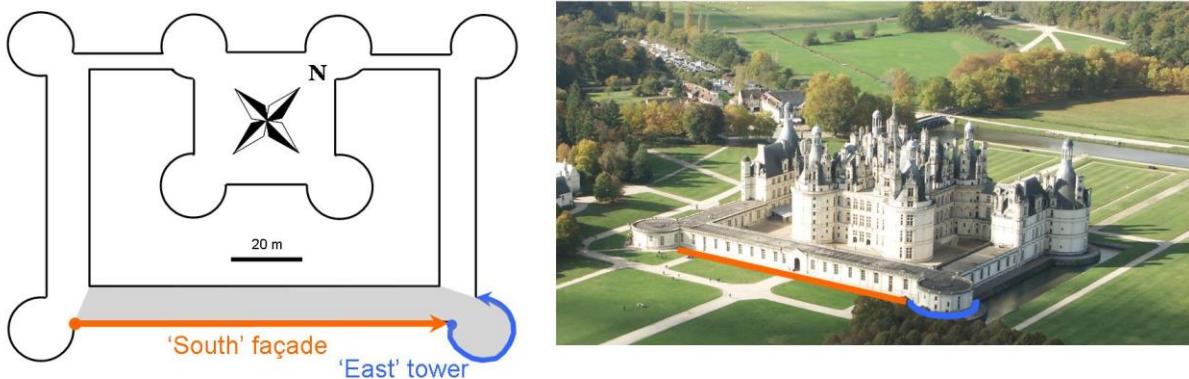
Fig. 1: The low surrounding building with the south façade and the east tower of Chambord castle

This paper aims to describe the history of stones used in the construction of Chambord castle mainly two sections dating from the first part of the 16th century: the south façade and the east tower (figure 1). The various type of degradations are then analysed considering the history of stones (implementation, restoration or replacement) and their location on the monument. The tower is located at the east of the castle, but the studied façade, is directed to the southeast, and commonly called "south façade". This façade, is the main entrance of the castle, was often modified by the various kings and owners, and often restored. The south façade is interesting to study because dates and provenances of replacements are various. The east tower was less valued and little restored. The stones of the tower are original, highly degraded and so of a great interest to this study, which aims to link types of stones, ages of stones and state of degradation and orientations and climatic conditions.

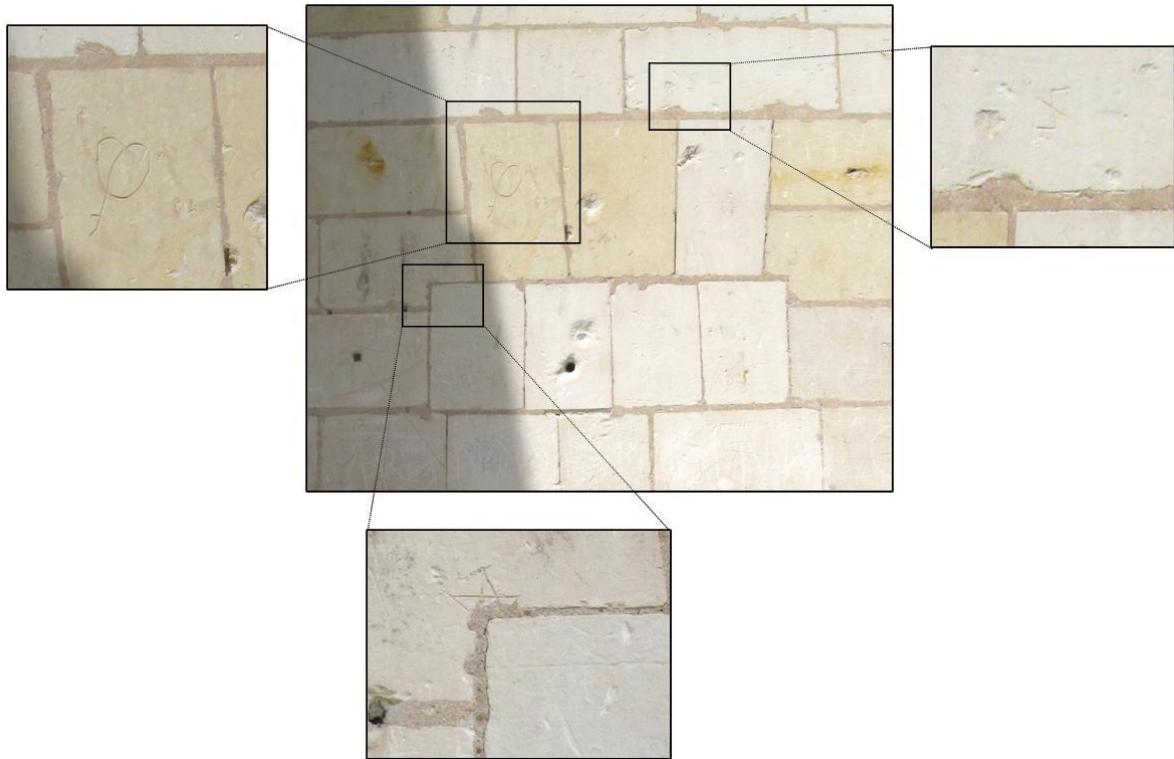
Fig. 2: South façade: door walled on the first left span, with a lapidary sign cut by the addition of a stone to the wall above the door, probably before 1555

Archaeology also provides important data. Many stones in Chambord castle show lapidary signs (Fig. 2). Often, each stone cutter engraved his own distinctive sign into the stones he sculpted. For plain vertical walls, workers were paid by the “toise” (area), or by the day. For carved sections (such as cornices, pilasters, mouldings and capitals), they were paid according to the task (e.g. the number of sculptures). On all these value added stones, lapidary signs were observed (Châtenet, 2001). These marks give guidance regarding the chronology of the works and the organisation of the construction process. They also allow us to identify stones dating from earlier stages of the building process. For the identification of the generic stone used in the façades, in addition to lapidary signs, archives provide important information, although it is sometimes incomplete.

Stones including lapidary signs on the south façade probably date back from the first stages of construction. Moreover, during the final phases of construction (between 1540 and 1545), interior transformations took place in the south façade (Bryant *et al.*, 2007), perhaps leading to the walling of nine small doors, which are still visible in front and detectable by their lintels (Fig. 2).

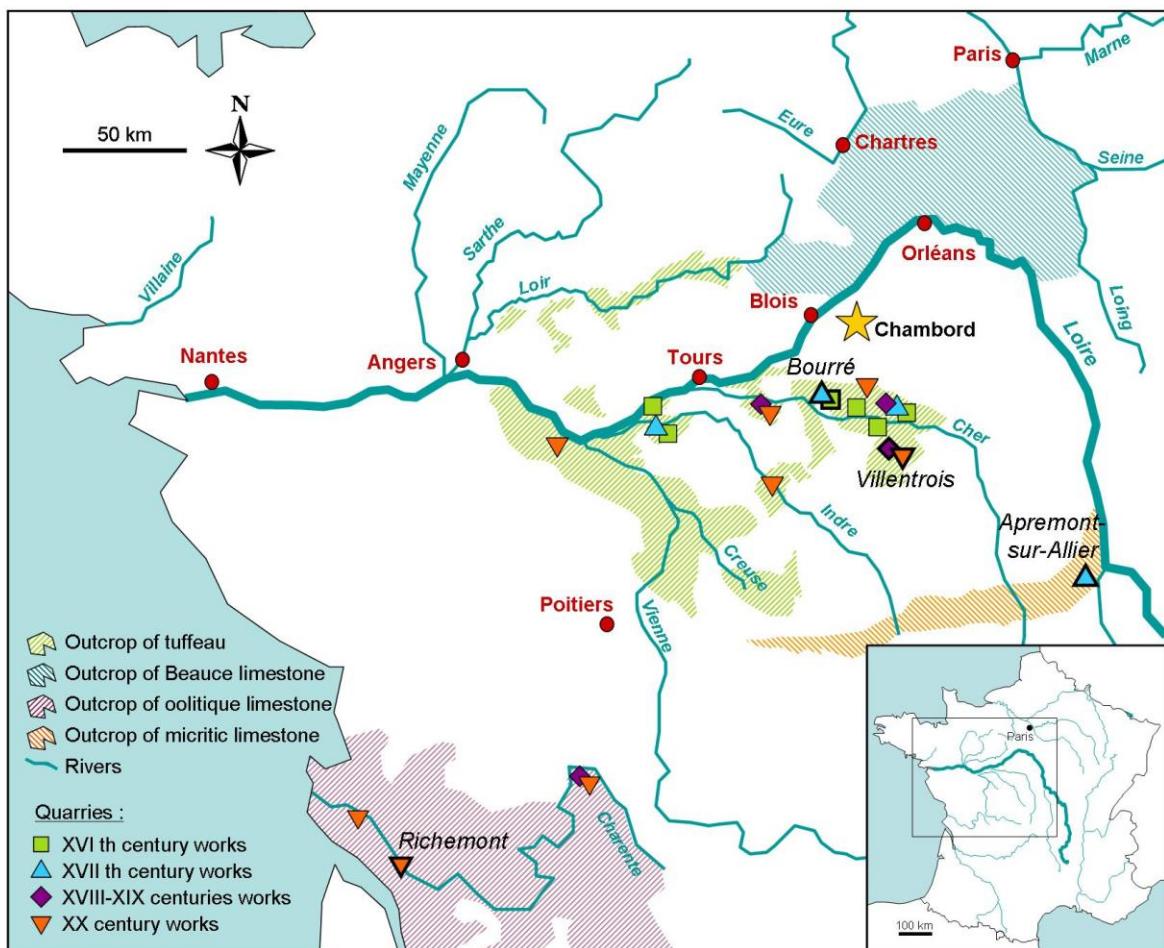
Fig. 3: Simplified map of the location of quarries used to the construction of the castle of Chambord (from Mussat, 1991; Rautureau, 2001; Yvard, 1976; Gorget, 1990)

Historically, tuffeau material is used for the construction of Chambord, due to its geographical proximity. The tuffeau of Bourré (see location in Fig. 3) is the dominant stone in the castle, in 16th century works. Texts say that tuffeau limestone used during the reign of Francois I for the construction came from six different quarries and were used to an equal extent without attention being paid to their strengths or physical characteristics (Penet, 1963).

Over the centuries, new tuffeau quarries are used as well as other harder limestones, more distant from the Loire. To replace tuffeau, oolithic limestone of Poitou-Charente has been much used from the 20th century (Fig. 3). So, in the early twentieth century, tuffeau quarries exploited are totally different from original tuffeau quarries. During the restoration of monuments, in the case of replacement stones, the question arises about the compatibility of these stones. Thus, in our example, for the South façade and the East tower, in the early twentieth century, the choice was to use only Richemont stone in substitution of tuffeau. At that time, many other tuffeau buildings were restored in Richemont stone, which is a white calcareous stone and considered more sustainable than tuffeau (Birginie, 2000; Dessandier, 2000). Richemont, limestone from quarries in Charente-Maritime, has the same geological age as tuffeau but with different properties from tuffeau (table 1). In the 90s, letters of architects and curators found in archives, show that considerations and guidelines of restoration are changing: Richmond stone is only used to make the transition between bases with hard limestone (Beauce limestone) and tuffeau facings. Finally, now, only Villentrois tuffeau is recommended by architects because it is considered similar to the original tuffeau: Bourré tuffeau⁵, very white tuffeaux, with fine grains (table 1), Quarries of Bourré no longer exist but the extraction of Villentrois tuffeau is near the old quarries of Bourré (Fig. 3).

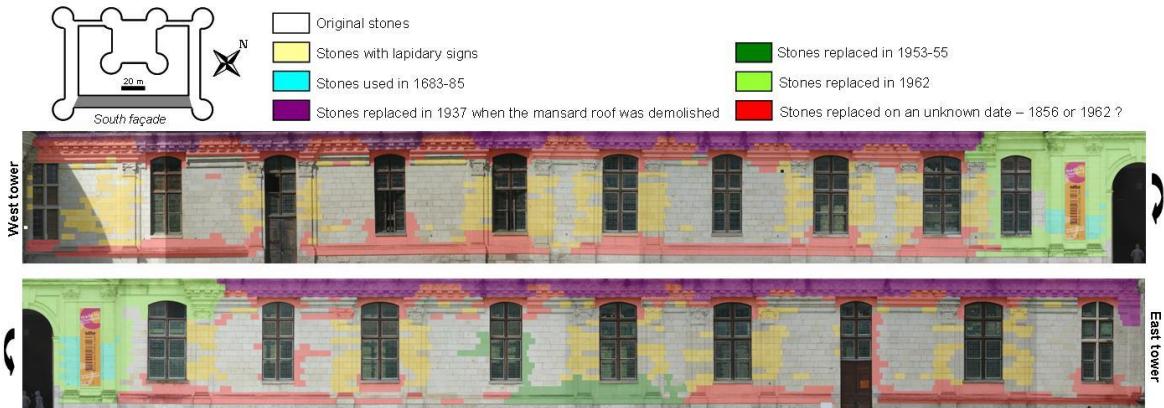
Based on lapidary signs, various stones from the south façade can be considered to be original, according to their dating (Fig. 4). In fact, from 1683, under Louis XIV, the Royal Portal and the adjacent span were completely rebuilt⁶. Also during this time, the southern parts of the castle, which were originally covered with terraces, were covered with a mansard roof (Paquet, 1937), windows were enlarged and parts above the windows were cut⁷. In this case, restoration seems to have involved cutting the existing stones, rather than replacing them. In 1937, a mansard roof was demolished and the cornices were restored. Stones were added above the windows in order to restore them to their original form. For these restorations, texts mentioned the use of "Salamander stones" from quarries of Saint-Même, in Charente. This stone has similar characteristics to those of Richemont stone, whose quarries are near (Fig. 3). This upper parts of the façade have been restored in 1856 or 1962 (sources are incomplete and we can not be sure)⁸.

In 1953, when the castle began to become a tourist destination, the reception desk was constructed. Stones under and around certain windows, on the right hand side of the south façade, were replaced on this occasion with Richemont limestone⁹. Finally, in 1962, the Royal Portal, which was badly damaged after the Second World War, was completely rebuilt, also with Richemont stone. The *stylobate* and numerous stones from the cornices also appear to have been restored with the same stones¹⁰. Quotations dating from 1856, and others dating from 1962, mention the replacement of these stones. However, the existence of quotations does not prove that the work was certainly done. Finally, since 1962, no more restorations have been carried out on the south façade.

Fig. 4: Distribution of various stone replacements on the south façade

The stones on the façades which have no colour code on the map can be considered as original stones (Fig. 4 and 5). The proportion of visible stones replaced during each period of restoration has been estimated using data from planar projection surfaces. These estimations cannot provide information regarding the volume of stones used. Moreover, these data should be treated with caution, as some dates for replacement may not be precise. However, this estimation gives the percentage of original visible stones (16th century), compared to the percentage of stones replaced later on. It indicates that nearly 50% of stones on the south façade have been replaced. This proportion differs from the east tower, where 80% of the stones are original. As the main entrance for public visitors to the castle is in the south façade, this façade has therefore been largely restored over the centuries, unlike the east tower, which is further back and away from tourist traffic. Moreover, the east tower has degraded to a greater extent than the south façade due to its location, as it overlooks the River Cosson, and is exposed to the wind.

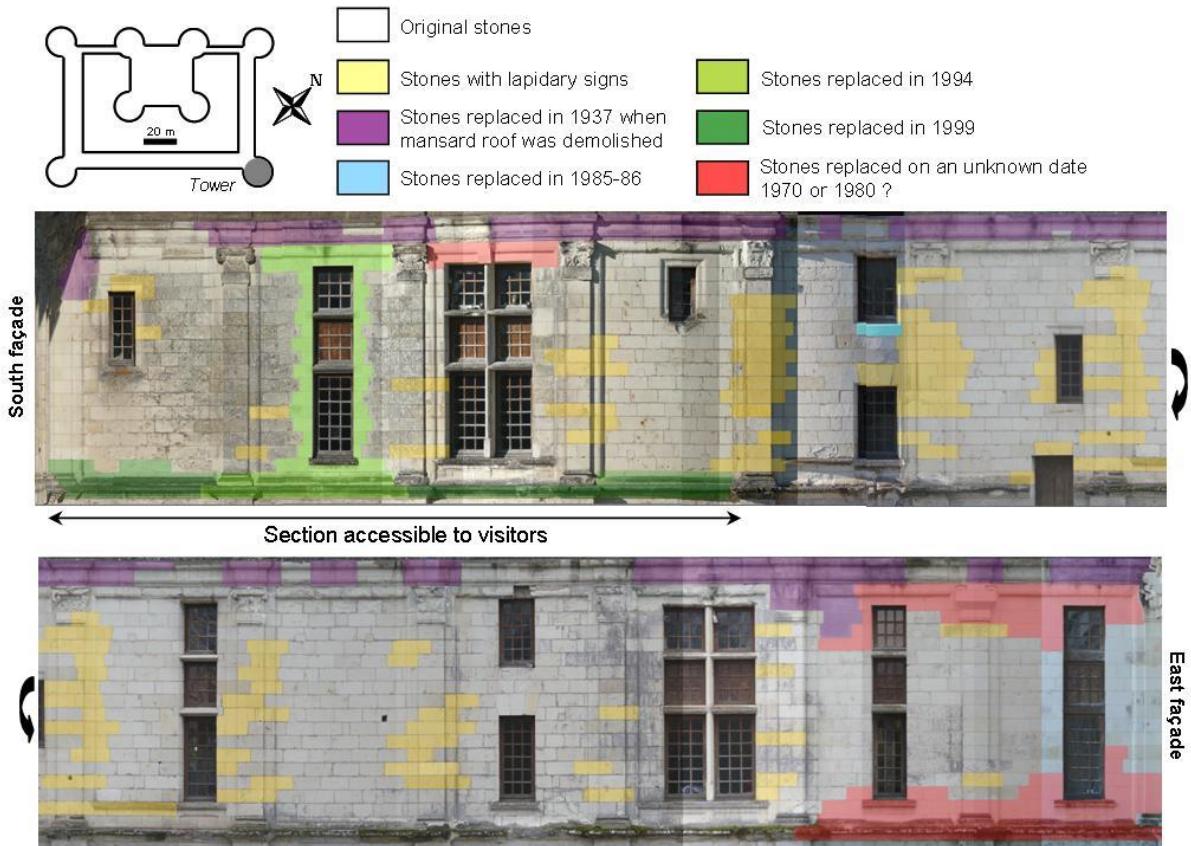
Unlike the south façade, the east tower underwent only a few rearrangements (Fig. 5). As for the south façade, stones with lapidary signs can be considered to date from the early phases of construction. The first mentions in the reports of stones being replaced date from 1937, when the floor under a mansard roof which had been established on all of the low surrounding buildings was destroyed and replaced by the original terraces. At that time, the upper parts of the tower were restored using salamander stones¹¹. Thereafter, guidelines of architects are to use stones close to the original: the Villentrois tuffeau is chosen. This tuffeau was used to make the fifth window from the left of the tower, it can be reliably dated from 1986¹². The *stylobate* stones in the first four spans of the tower, which are accessible to the public, were replaced between 1994¹³ and 1999¹⁴ with Richemont limestone and tuffeau from Villentrois. Spans not accessible to visitors are non restored for financial reasons. Window frame no. 2 was also replaced with tuffeau. Finally, on the last spans of the frieze, adjacent to the eastern façade, some new stones were added, which were probably Villentrois stones. The dates at which they were replaced can be estimated as being between 1970 and 1980¹⁵. This mapping shows that the stones were mainly replaced in the upper parts. These parts were the most degraded because they are in relief, and therefore stones are more exposed. The salient *stylobate*, now very impaired, was previously partially restored. Probably, during the next restoration of the east tower, the *stylobate* will be restored first.

Fig. 5: Distribution of various stones replacements in façades of the east tower

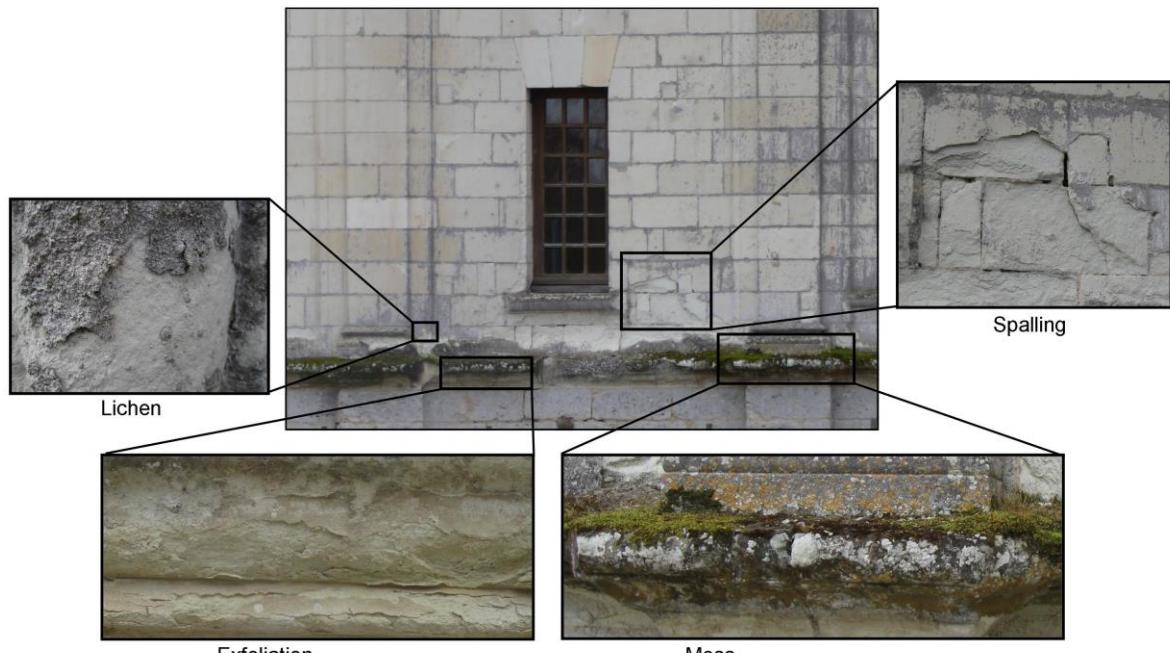
The detachment of stones with different thicknesses resulting in spalling or exfoliation can also be observed in the figure 6. Spalling is the most common form of degradation in the case of tuffeau, and the most damaging. It concerns carved stones, but also vertical facings, often initiated by reliefs (pilaster, windows). Over time, a plaque (one to three centimetres thicknesses) gradually forms on the surface of stone, and pells. The resulting stone surface turns into powder. The physico-chemical mechanism behind the formation of such plaque is still unclear, and many hypotheses have been advanced (Philippon, 1992; Dessandier, 1995; Imbault-Brunet, 1999; Rautureau, 2001; Thomachot, 2002; Beck, 2006). Testing samples have been taken on damaged areas of the castle of Chambord. The result of mineralogical characterization reveals physico-chemical degradation with presence of gypsum content in the powder zone on both sides of the cracking zone. Exfoliation mainly occurs in carved stones, which have a high specific surface area and thus a greater surface for evaporation. They also affect the lower parts of *stylobate* or cornices, which are generally more sheltered from the rain, and thus from leaching (ICOMOS-ISCS, 2008). The analysis showed the presence of gypsum in the leaves of exfoliations. The process of formation of these alterations and the origin of gypsum (air pollution, restoration mortars...) is not yet defined.

Fig. 6: Different types of alterations observed at Chambord – Example of the north part of the east tower

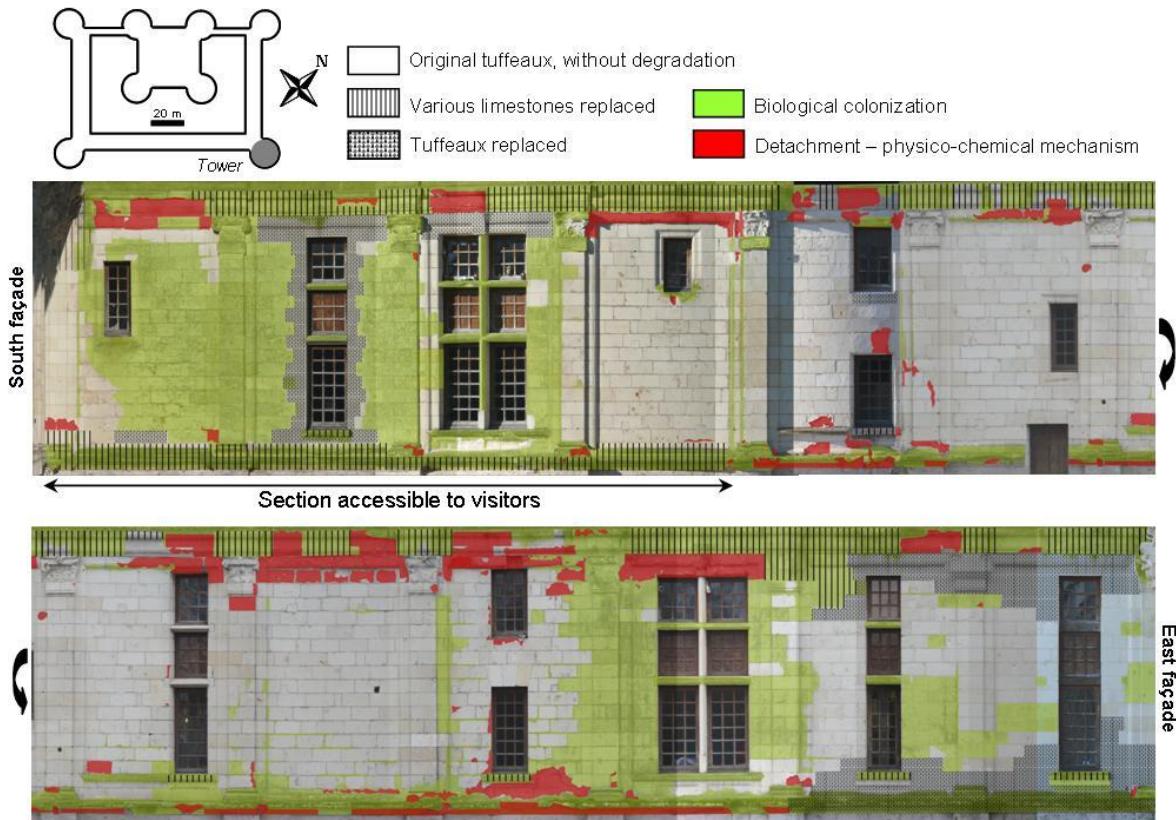
The east tower was less restored and more exposed to climatic variations than the south façade. So, the tower is more degraded. Figure 7 shows that physicochemical degradations affected the oldest tuffeau (red zone), but not yet stones replaced in the 20th century, tuffeau (squared zone) or Richemont stone (striped zone), because physicochemical degradations are a long process, conversely to biological degradations. Indeed, there is no observable relationship between biological alterations (green zone) and the age or provenance of the stone. The relief, the disposition and the orientation of the stones determine the location of biological alterations: a cornice with a horizontal relief is usually more covered with moss (because of water accumulation) than a vertical face (which dries quickly). So, vertical walls are colonized less rapidly than horizontal areas, as shown on the second bay of the tower.

Fig. 7: Age and decay features of stones in the east tower

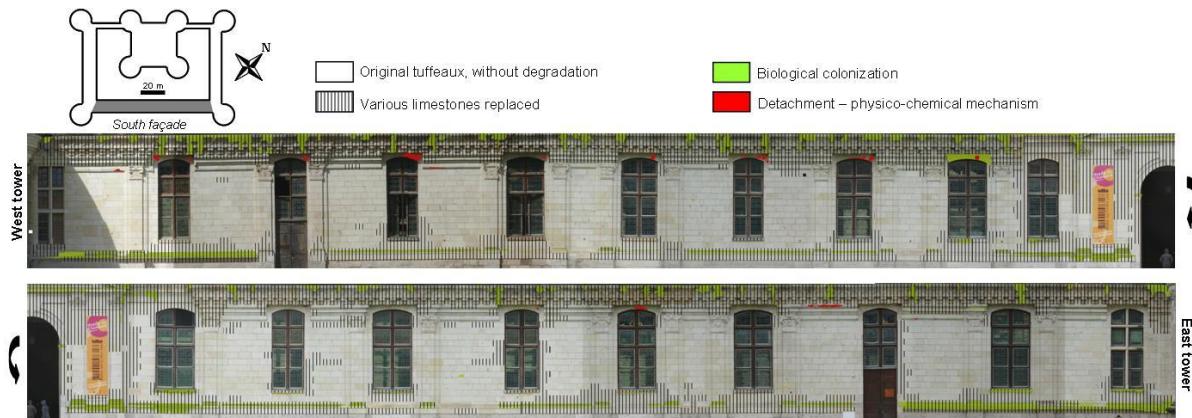
The mapping in figure 8 shows that the south façade is less degraded than the east tower. Spallings (red zone) are only located on ancient tuffeau. Concerning the degraded parts above the windows, doubt remains about their replacement date. If they had been restored in 1962, they would not be much degraded. They probably were restored in 1853, but we do not know if original tuffeaux was just re-cut on the surface or replaced with new tuffeau.

Fig. 8: Age and decay features of stones in the south façade

Visually, in the south façade, spalling are less developed than in the northern parts of the tower, probably because the south facade was restored very often, mostly with Richemont stone (striped zone). Compared to Tuffeau, Richemont stone is more resistant, less porous and so less sensitive to spalling. Moreover, physicochemical degradations are not observed on Richemont stone recently placed in the castle (less than 60 years ago) because it's well known that these types of decay are time dependent. Colonizations (green zone) are less present than on the tower, because of the orientation of the façade (very sunny, like the five center spans of the tower). The development of micro-organisms and then, lichens and mosses, is difficult and slow on a dried wall. But the areas with relief have sometimes biological degradation, because they retain moisture (green zone with superimposition of striped zone).
