A historical study of Chambord castle: A basis for establishing the health record of the monument

Sarah Janvier-Badosa, Kévin Beck, Xavier Brunetaud, Muzahim Al-Mukhtar

Abstract:

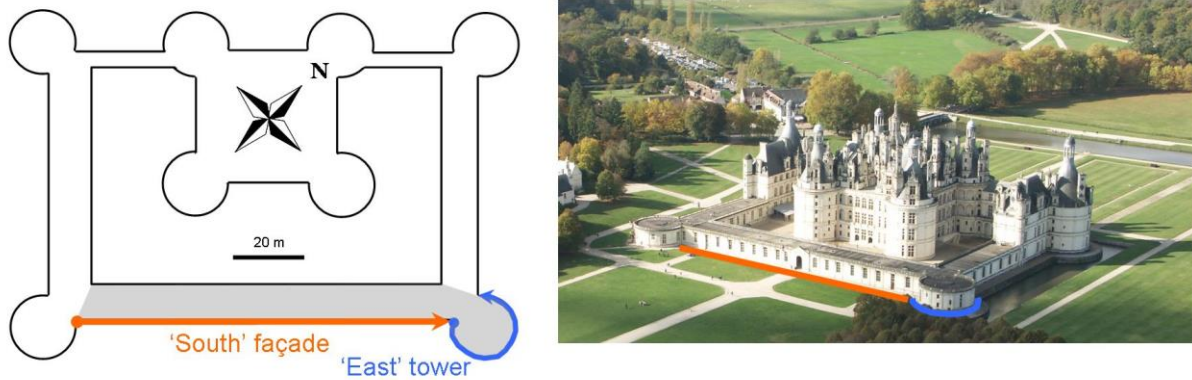
Fig. 1: The low surrounding building with the south façade and the east tower of Chambord castle

This paper aims to describe the history of stones used in the construction of Chambord castle mainly two sections dating from the first part of the 16th century: the south façade and the east tower (figure 1). The various type of degradations are then analysed considering the history of stones (implementation, restoration or replacement) and their location on the monument. The tower is located at the east of the castle, but the studied façade, is directed to the southeast, and commonly called "south façade". This façade, is the main entrance of the castle, was often modified by the various kings and owners, and often restored. The south façade is interesting to study because dates and provenances of replacements are various. The east tower was less valued and little restored. The stones of the tower are original, highly degraded and so of a great interest to this study, which aims to link types of stones, ages of stones and state of degradation and orientations and climatic conditions.

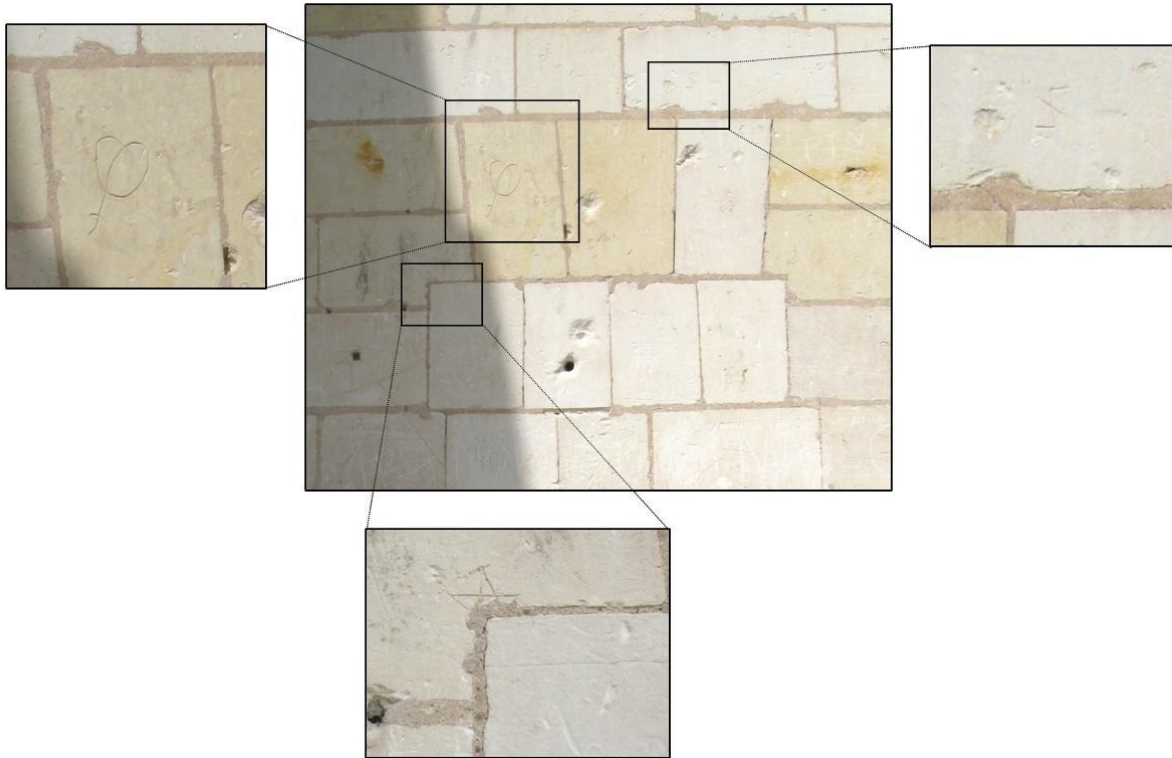
Fig. 2: South façade: door walled on the first left span, with a lapidary sign cut by the addition of a stone to the wall above the door, probably before 1555

Archaeology also provides important data. Many stones in Chambord castle show lapidary signs (Fig. 2). Often, each stone cutter engraved his own distinctive sign into the stones he sculpted. For plain vertical walls, workers were paid by the “toise” (area), or by the day. For carved sections (such as cornices, pilasters, mouldings and capitals), they were paid according to the task (e.g. the number of sculptures). On all these value added stones, lapidary signs were observed (Châtenet, 2001). These marks give guidance regarding the chronology of the works and the organisation of the construction process. They also allow us to identify stones dating from earlier stages of the building process. For the identification of the generic stone used in the façades, in addition to lapidary signs, archives provide important information, although it is sometimes incomplete.

Stones including lapidary signs on the south façade probably date back from the first stages of construction. Moreover, during the final phases of construction (between 1540 and 1545), interior transformations took place in the south façade (Bryant *et al.*, 2007), perhaps leading to the walling of nine small doors, which are still visible in front and detectable by their lintels (Fig. 2).

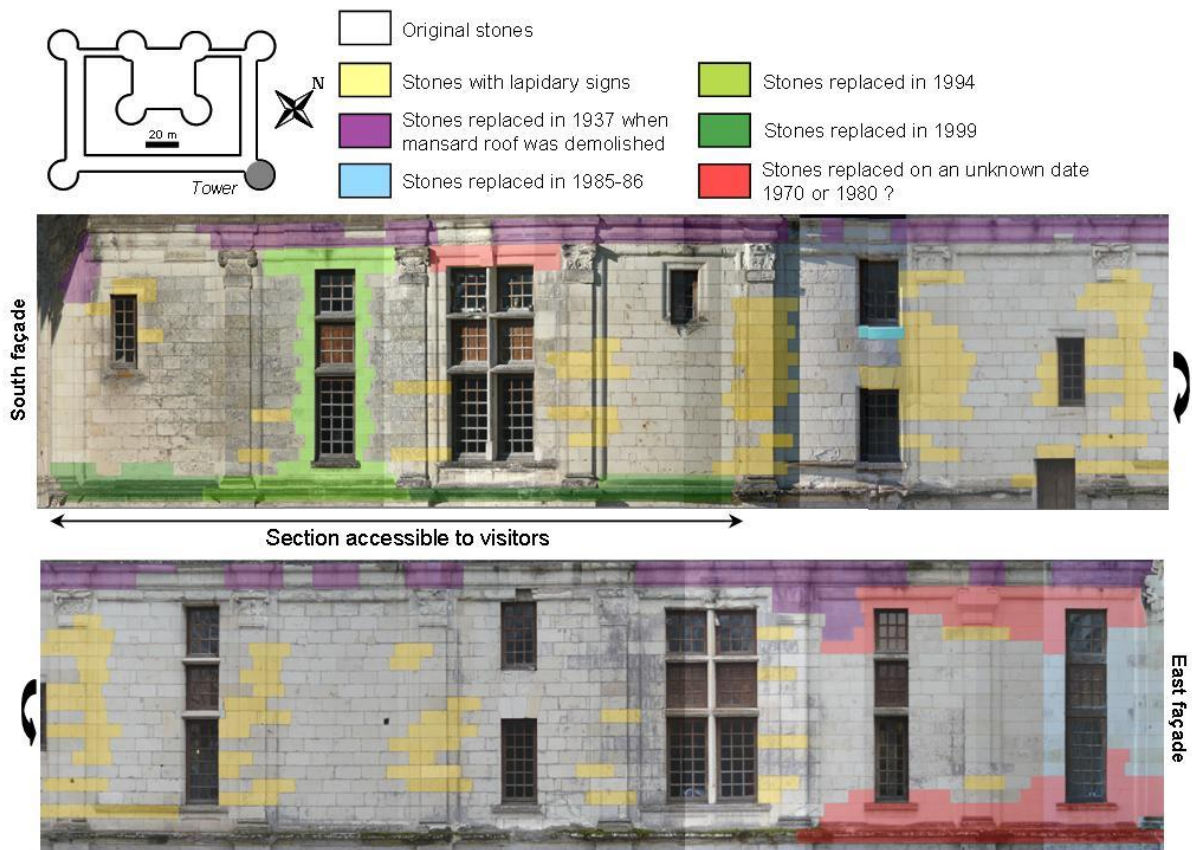
Unlike the south façade, the east tower underwent only a few rearrangements (Fig. 5). As for the south façade, stones with lapidary signs can be considered to date from the early phases of construction. The first mentions in the reports of stones being replaced date from 1937, when the floor under a mansard roof which had been established on all of the low surrounding buildings was destroyed and replaced by the original terraces. At that time, the upper parts of the tower were restored using salamander stones¹¹. Thereafter, guidelines of architects are to use stones close to the original: the Villentrois tuffeau is chosen. This tuffeau was used to make the fifth window from the left of the tower, it can be reliably dated from 1986¹². The *stylobate* stones in the first four spans of the tower, which are accessible to the public, were replaced between 1994¹³ and 1999¹⁴ with Richemont limestone and tuffeau from Villentrois. Spans not accessible to visitors are non restored for financial reasons. Window frame no. 2 was also replaced with tuffeau. Finally, on the last spans of the frieze, adjacent to the eastern façade, some new stones were added, which were probably Villentrois stones. The dates at which they were replaced can be estimated as being between 1970 and 1980¹⁵. This mapping shows that the stones were mainly replaced in the upper parts. These parts were the most degraded because they are in relief, and therefore stones are more exposed. The salient *stylobate*, now very impaired, was previously partially restored. Probably, during the next restoration of the east tower, the *stylobate* will be restored first.

Fig. 5: Distribution of various stones replacements in façades of the east tower

The stones on the façades which have no colour code on the map can be considered as original stones (Fig. 4 and 5). The proportion of visible stones replaced during each period of restoration has been estimated using data from planar projection surfaces. These estimations cannot provide information regarding the volume of stones used. Moreover, these data should be treated with caution, as some dates for replacement may not be precise. However, this estimation gives the percentage of original visible stones (16th century), compared to the percentage of stones replaced later on. It indicates that nearly 50% of stones on the south façade have been replaced. This proportion differs from the east tower, where 80% of the stones are original. As the main entrance for public visitors to the castle is in the south façade, this façade has therefore been largely restored over the centuries, unlike the east tower, which is further back and away from tourist traffic. Moreover, the east tower has degraded to a greater extent than the south façade due to its location, as it overlooks the River Cosson, and is exposed to the wind.

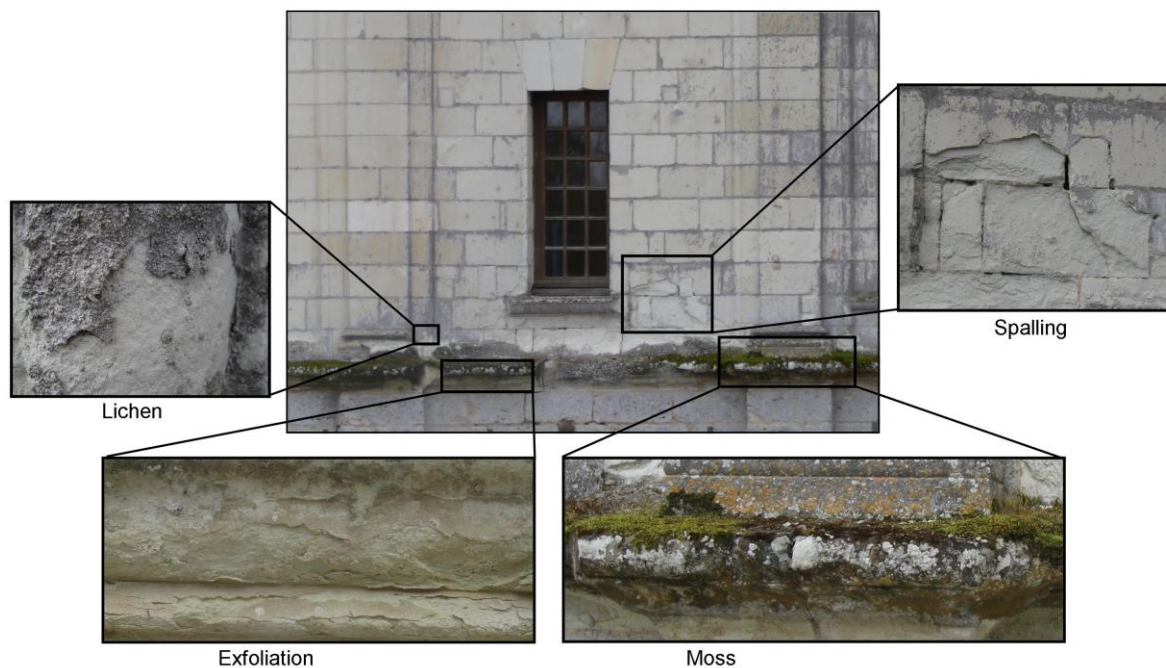
The detachment of stones with different thicknesses resulting in spalling or exfoliation can also be observed in the figure 6. Spalling is the most common form of degradation in the case of tuffeau, and the most damaging. It concerns carved stones, but also vertical facings, often initiated by reliefs (pilaster, windows). Over time, a plaque (one to three centimetres thicknesses) gradually forms on the surface of stone, and peels. The resulting stone surface turns into powder. The physico-chemical mechanism behind the formation of such plaque is still unclear, and many hypotheses have been advanced (Philippon, 1992; Dessandier, 1995; Imbault-Brunet, 1999; Rautureau, 2001; Thomachot, 2002; Beck, 2006). Testing samples have been taken on damaged areas of the castle of Chambord. The result of mineralogical characterization reveals physico-chemical degradation with presence of gypsum content in the powder zone on both sides of the cracking zone. Exfoliation mainly occurs in carved stones, which have a high specific surface area and thus a greater surface for evaporation. They also affect the lower parts of *stylobate* or cornices, which are generally more sheltered from the rain, and thus from leaching (ICOMOS-ISCS, 2008). The analysis showed the presence of gypsum in the leaves of exfoliations. The process of formation of these alterations and the origin of gypsum (air pollution, restoration mortars...) is not yet defined.

Fig. 6: Different types of alterations observed at Chambord – Example of the north part of the east tower

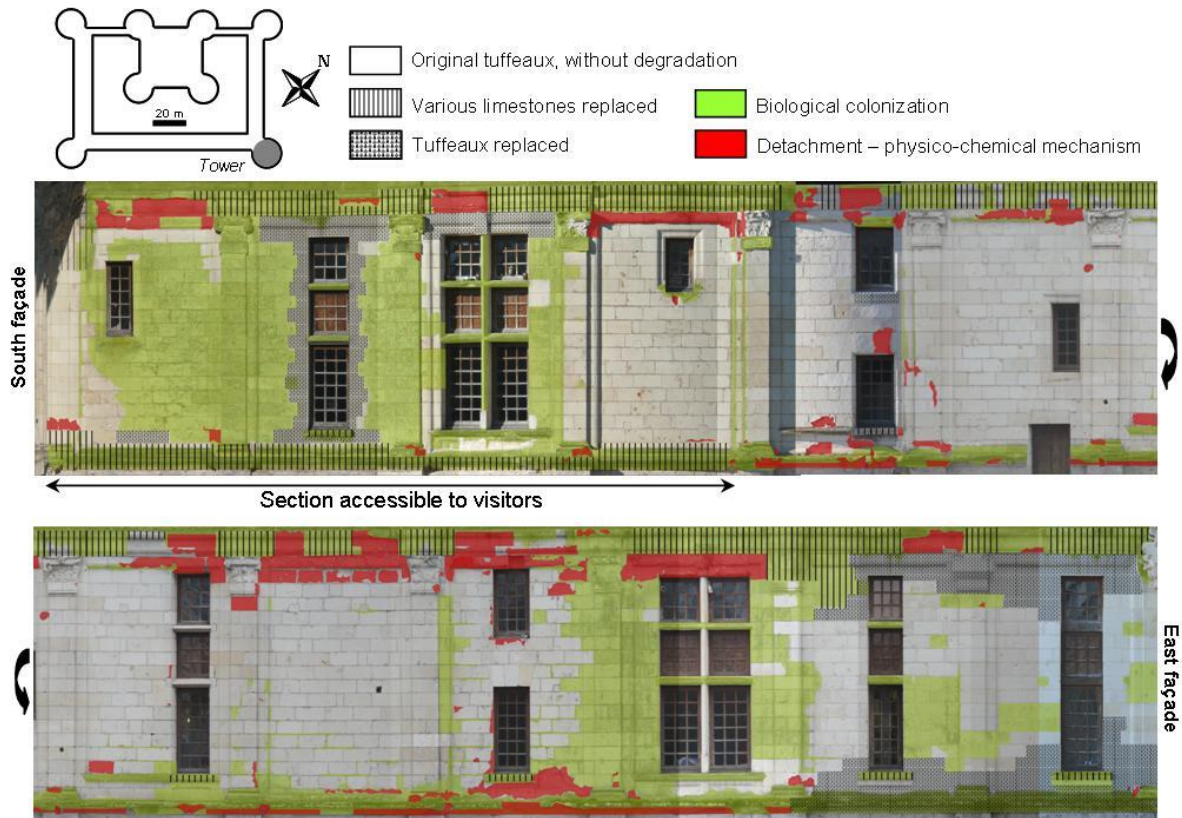
The east tower was less restored and more exposed to climatic variations than the south façade. So, the tower is more degraded. Figure 7 shows that physicochemical degradations affected the oldest tuffeau (red zone), but not yet stones replaced in the 20th century, tuffeau (squared zone) or Richemont stone (striped zone), because physicochemical degradations are a long process, conversely to biological degradations. Indeed, there is no observable relationship between biological alterations (green zone) and the age or provenance of the stone. The relief, the disposition and the orientation of the stones determine the location of biological alterations: a cornice with a horizontal relief is usually more covered with moss (because of water accumulation) than a vertical face (which dries quickly). So, vertical walls are colonized less rapidly than horizontal areas, as shown on the second bay of the tower.

Fig. 7: Age and decay features of stones in the east tower

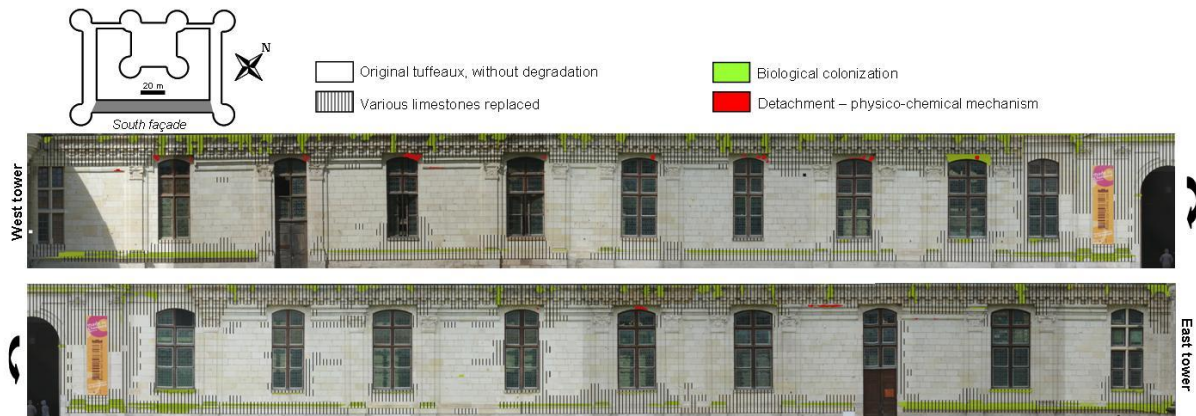
The mapping in figure 8 shows that the south façade is less degraded than the east tower. Spallings (red zone) are only located on ancient tuffeau. Concerning the degraded parts above the windows, doubt remains about their replacement date. If they had been restored in 1962, they would not be much degraded. They probably were restored in 1853, but we do not know if original tuffeaux was just re-cut on the surface or replaced with new tuffeau.

Fig. 8: Age and decay features of stones in the south façade

Visually, in the south façade, spalling are less developed than in the northern parts of the tower, probably because the south facade was restored very often, mostly with Richemont stone (striped zone). Compared to Tuffeau, Richemont stone is more resistant, less porous and so less sensitive to spalling. Moreover, physicochemical degradations are not observed on Richemont stone recently placed in the castle (less than 60 years ago) because it's well known that these types of decay are time dependent. Colonizations (green zone) are less present than on the tower, because of the orientation of the façade (very sunny, like the five center spans of the tower). The development of micro-organisms and then, lichens and mosses, is difficult and slow on a dried wall. But the areas with relief have sometimes biological degradation, because they retain moisture (green zone with superimposition of striped zone).
