2014 IOP Conf. Ser.: Mater. Sci. Eng. 63 012020

Plastic deformation to enhance plasma-assisted nitriding: On surface contamination induced by Surface Mechanical Attrition Treatment

Abstract. The Surface Mechanical Attrition Treatment is a recent technique leading to the formation of nanostructured layers by the repeated action of impacting balls. While several communications have revealed possible contamination of the SMATed surfaces, the nature of this surface contamination was analyzed in the present contribution for the treatment of an AISI 316L stainless steel. It is shown, by a combination of Transmission Electron Microscopy and Glow Discharge - Optical Emission Spectrometry, that the surface was alloyed with Ti, Al and V coming from the sonotrode that is used to move the balls as well as Zr coming from the zirshot® balls themselves.

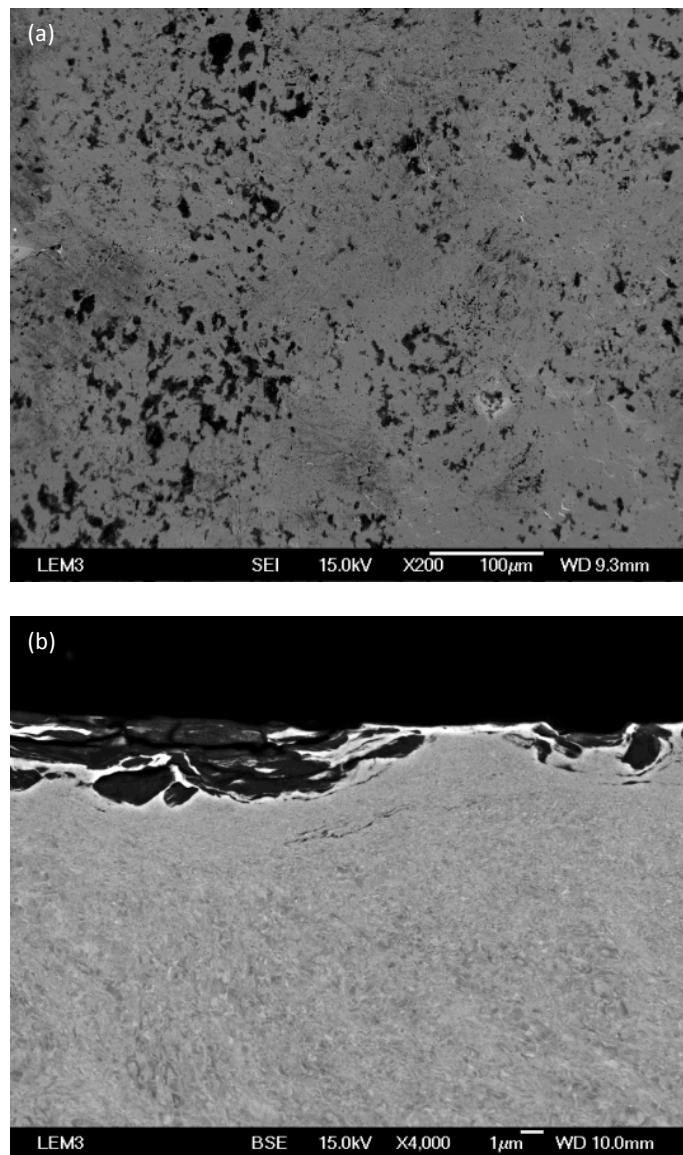
Figure 1: SEM images showing the (a) surface morphology and (b) the cross section microstructure after 316L SS SMATed under 80 μm of amplitude for 20 min with 100Cr6 balls.

The microstructures and deformation mechanisms taking place in the 316L SS during the SMAT process have been already detailed in [6, 19, 20]. The first stage of the grain subdivision is controlled by the formation of planar dislocation arrays and twins. Then, as strain is increased, several twin systems and, depending on the exact chemistry of the alloy [6], the martensitic transformation are activated to refine further the average grain size [6, 18, 19]. Figure 1 shows SEM images, acquired under Backscattered Electron imaging conditions, from the top surface and a cross-sectional view of a sample treated by SMAT with the 100C6 balls for the most severe conditions (20 min, 80 μm). Dark spots can be seen at the top surface in Fig. 1 (a). The analysis of the cross-section in Fig 1 (b) shows that they correspond to local contaminated domains, the thickness of which can reach about 4 μm in some zones.

A bright field TEM image showing a surface contaminated domain is given in Figure 2. Two zones having different aspects and different chemistry are observed. The local EDX chemical analyses of the two zones are given in Figs. 2 b and c. The bottom left of the image in Fig. 2a corresponds to the base material in which, consistently with earlier studies [6, 9, 18, 19], it is observed that the heavy deformation has generated the presence of nano-grains. Consistently with the chemistry of the base austenitic steel, peaks of Fe, Ni, Cr, Mn and Mo are clearly depicted. It is important to note that the high intensity of the Cu peak is due to electrons interacting with the sample holder in the TEM. The top right of the image corresponds to a contaminated domain revealed in Fig 1. In addition to some of the initial chemical elements

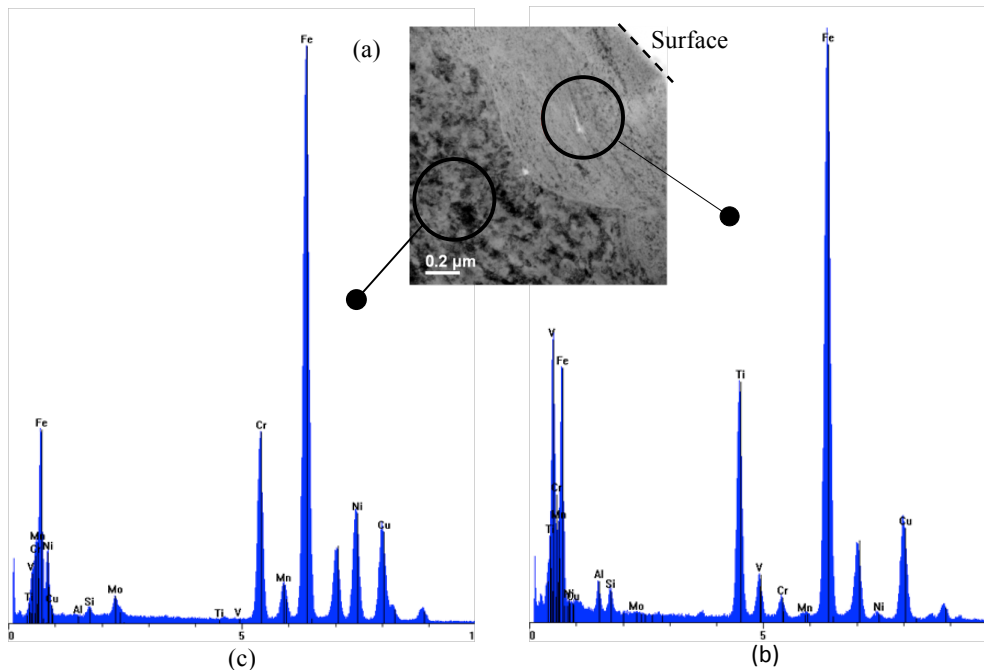
Figure 2: (a) TEM bright field image presenting the zones where the EDX analysis was carried out. (b) At the top surface layer, (c) at the subsurface after 316L SS SMATed under 80 μm of amplitude for 20 min with 100Cr6 balls.

present in the 316L sample, the analysis of the top surface reveals the presence of other elements such as Ti, Al and V. This indicates that external elements were introduced during the SMAT treatment. In the present case of the specific contamination analyzed here, the chemical species introduced within the surface are the constituting elements of the Ti-6Al-4V alloy from which the sonotrode is made of.

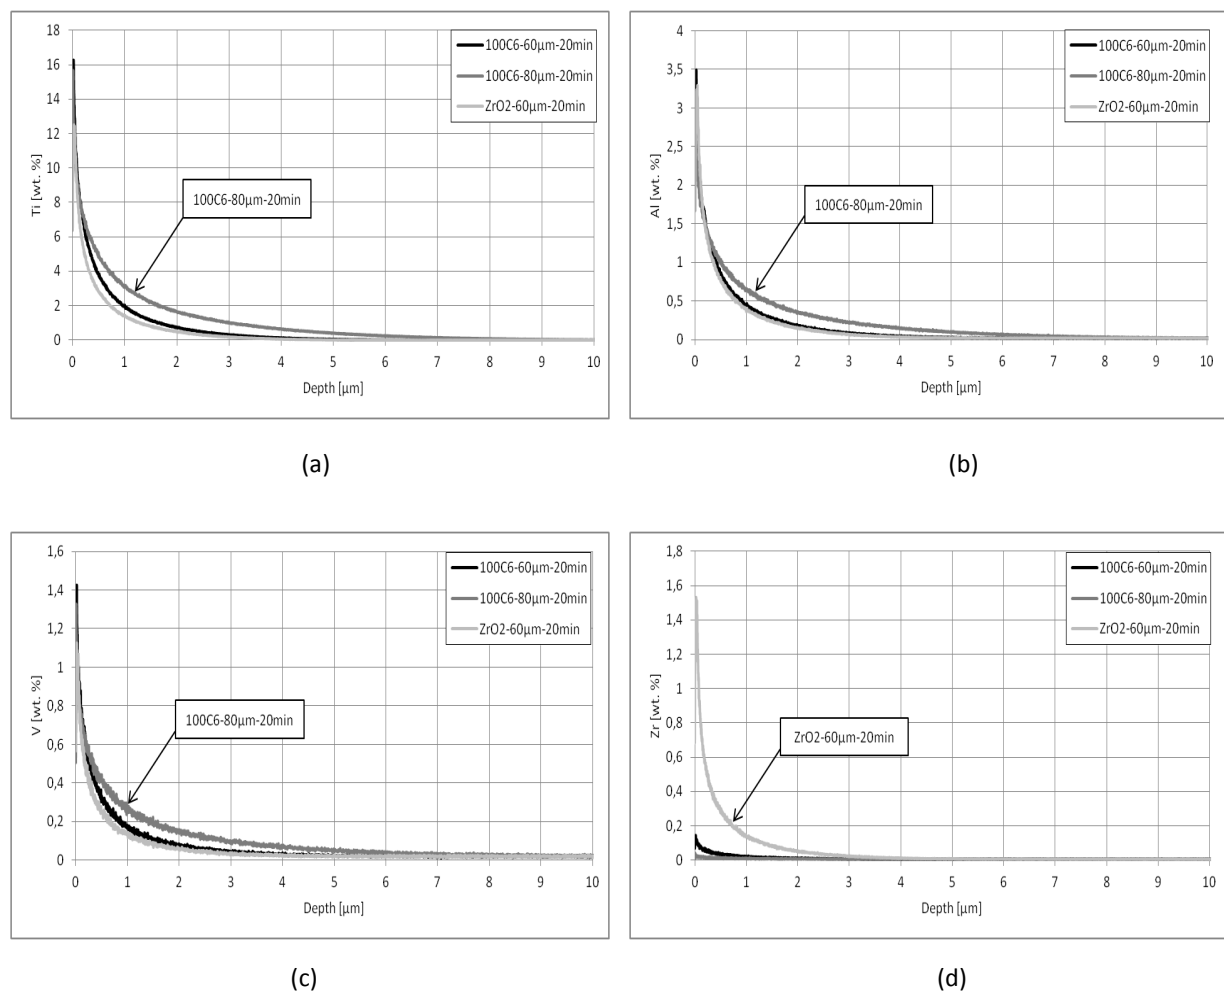
Figure 3: GD-OES in-depth surface chemical composition (wt%) evolution of (a) Titanium, (b) Aluminum, (c) Vanadium and (d) Zirconium for samples SMATed under different SMAT conditions.

To gain a more statistical insight on the exact nature of the surface contaminations, a GD-OES analysis was carried out on different samples treated under various SMAT conditions. Figure 3 shows the GD-OES results corresponding to the content (wt%) of the different chemical elements expressed as a function of the distance from the top surface. As the data are averaged over a surface of 12 mm² and because of the surface roughness induced by the SMAT process, the curves only give a qualitative trend of the amount of contamination.

It is firstly observed (in Fig. 3 (a)) that Ti is present in a significant amount at the surface in comparison with the other contaminating elements. Its content reaches an average of about 10 wt% at the top surface and its presence is detected over a maximum depth of about 9 μm for the sample treated with the most severe conditions (80 μm / 20 min). On the same sample, contents are reaching about 4 wt% in Al and 2 wt% in V, for the same maximum affected depth of about 9 μm. Their relative contents and this similar penetration depth confirm that these 3 elements were introduced as the consequence of some material removal from the sonotrode that was subsequently transferred to the sample surface and incorporated into the substrate under the peening process. Concerning the nature of the

surface pollution, a second interesting result is the detection of zirconium for the sample treated with the Zirshot® balls (figure 3 (d)). Its amount is globally lower with content that do not exceed 1.5 wt% for a maximum depth of 4 μm . This element is only observed when Zirshot® balls are used, indicating thereby that the balls also transfer some of their chemical elements. Because of the nature of the treated samples, the contamination of the sample surface induced by the 100Cr6 balls is less easy to detect.

To summarize, it is observed that the contaminated depths and the elements content are different as a function of the SMAT parameters. It is observed that increasing the sonotrode magnitude results in slightly higher Ti, Al and V concentrations while it is also clear that the nature of the balls has an influence on the surface contamination.
