# GIS Utility For Hydrological Impact Evaluation Caused By Damages Of Water Supply Network In Rural Areas. Applications In Baia Mare Depression

Radu Alexandru Marian, Ionel Haidu, Augustin Ionuț Crăciun, Bogdan Văduva

Radu Alexandru Marian, Ionel Haidu, Augustin Ionuț Crăciun, Bogdan Văduva. GIS Utility For Hydrological Impact Evaluation Caused By Damages Of Water Supply Network In Rural Areas. Applications In Baia Mare Depression. *Geographia Napocensis*, 2012, VI (2). hal-02488191

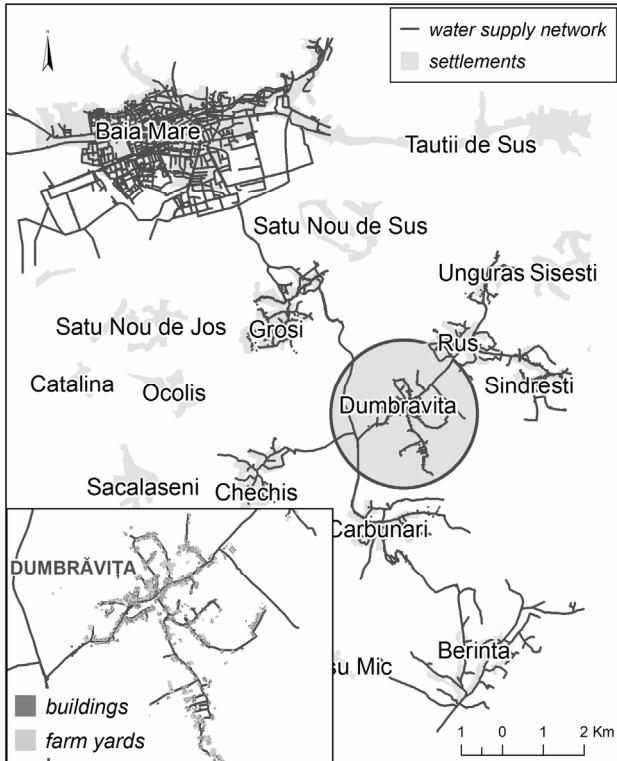
Fig. 1 Employment in the territory of water supply network and Dumbrăvița settlement

The study area is located in Baia Mare Depression and overlaps water systems connected with the Baia Mare in the south and southeast; case studies of this work will be done on the level of Dumbrăvița settlement [Fig. 1].

Water supply network of Baia Mare city and south and southeast of it comprises a total of 2230 sections of pipe. Of the 2230 sections of pipe situation in the rural settlements is as follows: Chechiș - 39 sections; Unguraș - 11 sections; Berința - 54 sections; Cărbunari - 42

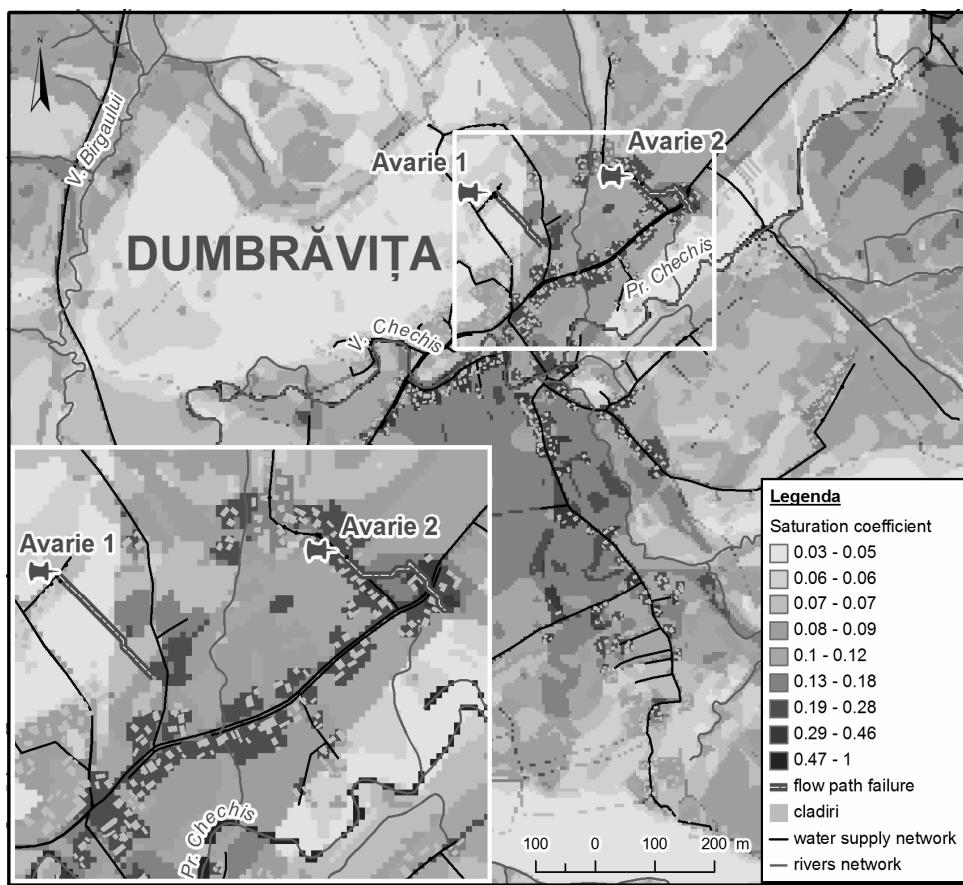
Fig. 2 Water saturation coefficient map and location of damages (15-05-2010)

In [fig. 2] we present the water saturation coefficient map which can be observed on most of the territory, low soil water saturation for the day 15/05/2010. Saturation coefficients from 0.4 to 0.5 can be found only if beds and floodplains of watercourses or built village (farm yards) on land with low slope.

Calculation methodology presented in the previous section was applied to the village Dumbrăvița, considering the time of the accident on the 15/05/2010 with two scenarios of damage to pipelines (Avarie 1 and Avarie 2) [Fig. 2].

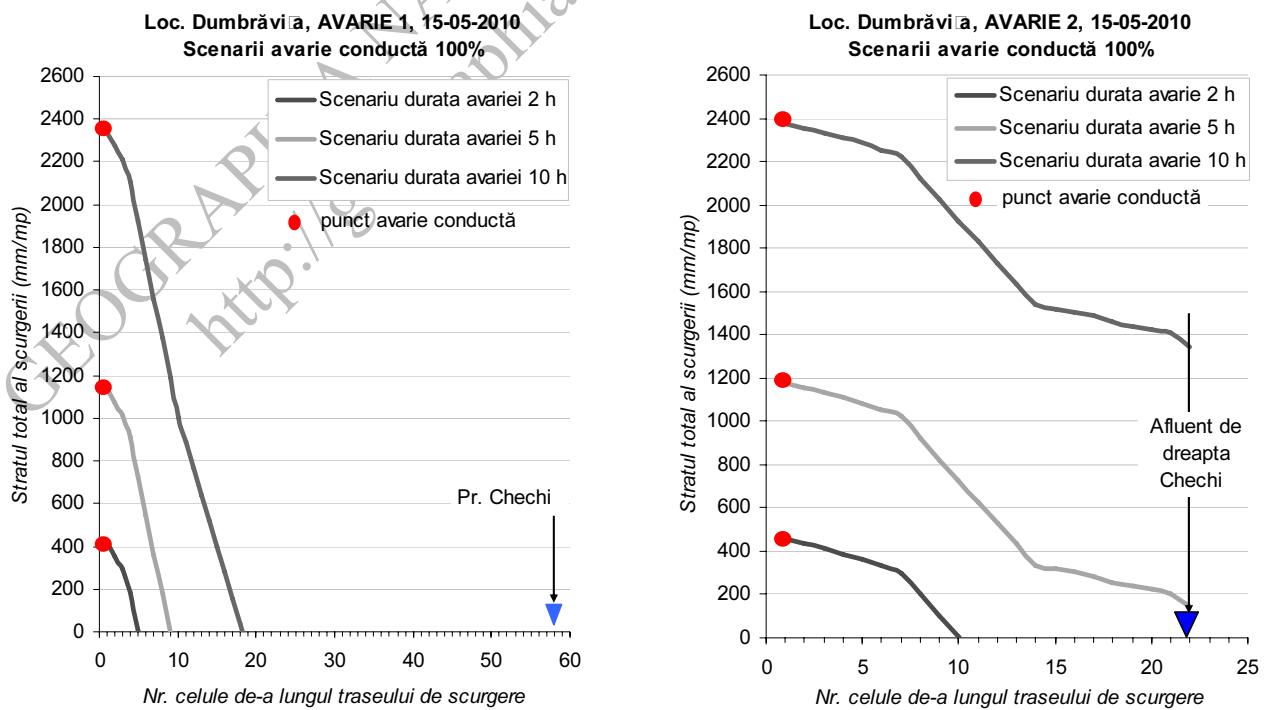
Fig. 3 Results of surface runoff along the flow path for different scenarios of the fault. Hypothesis: Water damage causes loss of 100% of the average volume of water carried by pipeline

Further calculation was performed for each cell runoff point along the flow path considering three scenarios regarding the duration of damage (2h, 5h, 10h). In fig. 3 presents results on the flow chart for the two cases of damages where the explosion would take place pipe (100% water loss, approx.  $24 \text{ m}^3/\text{h}$  water flow in the pipe as it is in the study area).

The average discharge of water in pipes of  $24 \text{ m}^3/\text{sa}$  was obtained from measurements made in the study area. Office Water Loss in SC VITAL, Baia Mare conducted a series of campaigns to measure water discharge in different strategic points in the city and in rural water taken from the water operator SC Vital SA.

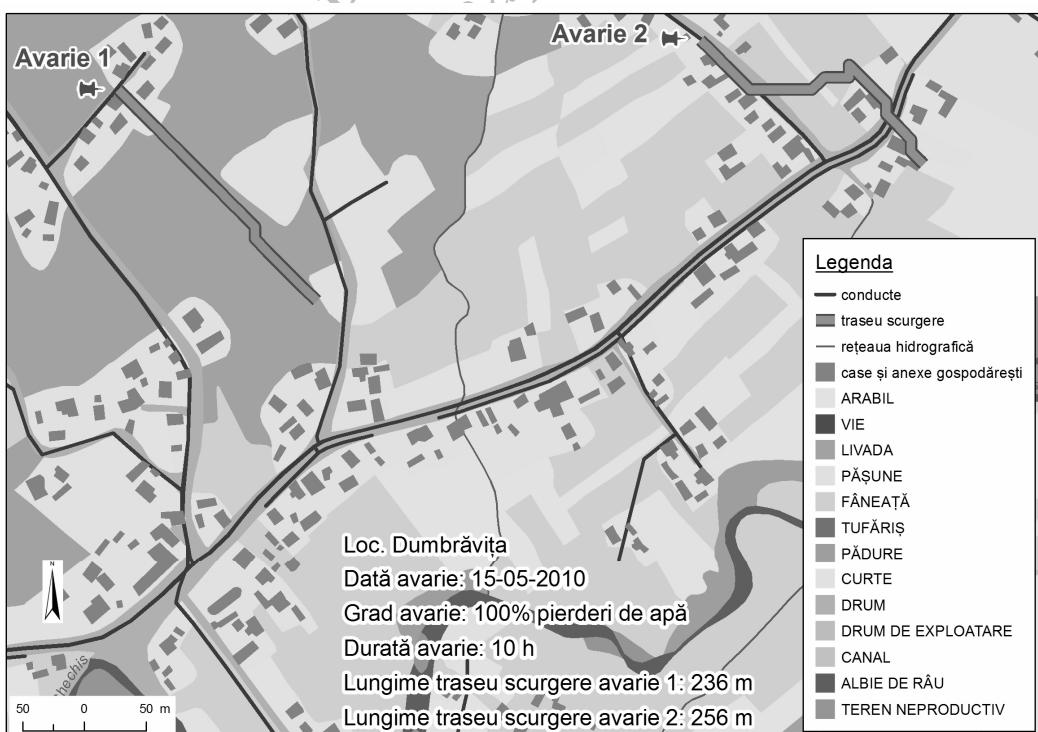
Fig. 4 Map parcels and households affected

In this chapter we turn therefore attention to the following lines of analysis: the impact on households (farm yard, house, household), the impact on road and rail routes, impact on crops. We present an example in [Fig. 4] records categories of land likely to be affected by flooding or excess moisture for the two scenarios from the village Dumbrăvița damage if pipes burst and the duration of such failure for 10 h.
