Impact des conditions environnementales sur le comportement à long terme de sols traités

Nicolas Chabrat. Impact des conditions environnementales sur le comportement à long terme de sols traités. Sciences de l'ingénieur [physics]. Université de Lorraine, 2024. Français. NNT : 2024LORR0004 . tel-04585485

Laboratoire d'Énergétique et de Mécanique Théorique et Appliquée (LEMMA)

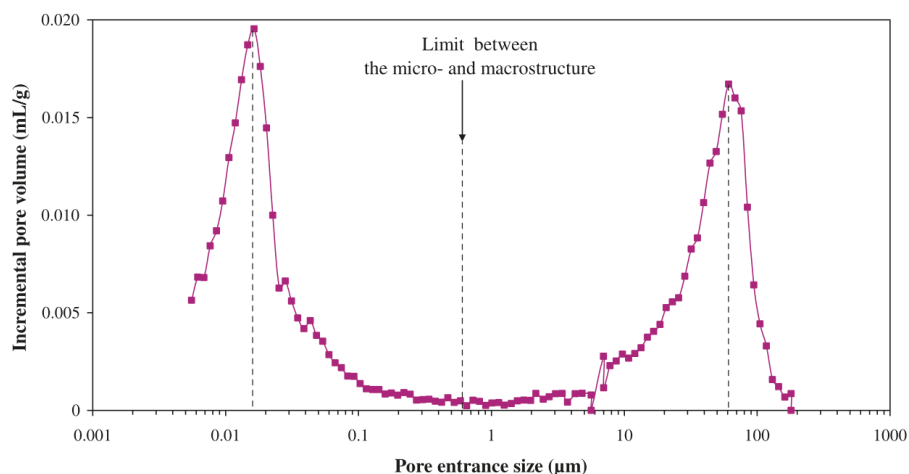
Ces deux différentes classes de pores peuvent être observées par l'intermédiaire de l'essai de porosimétrie au mercure (par ex. (Diamond, 1971; Delage et al., 1996; Russo et al., 2007; Al-Mukhtar et al., 2012; Houhou et al., 2021). Nowamooz et al. (2009) ont étudié la microstructure d'une argile fortement plastique. La répartition de la densité des pores obtenue présente deux pics : le premier à environ 0,01 - 0,02 μm correspondant aux micropores du matériau et le deuxième à environ 50 - 70 μm correspondant aux macropores (Figure I.3).

Figure I.3. Répartition de la taille des pores d'une argile (Nowamooz et al., 2009).

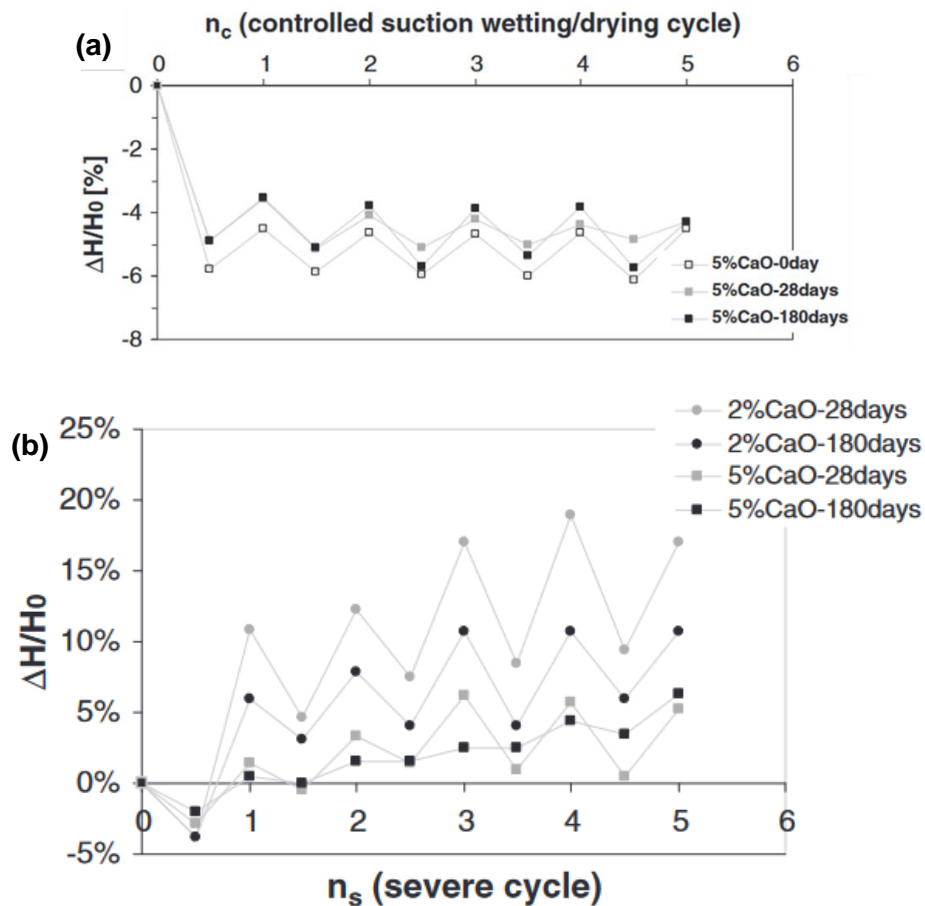
Figure I.25. Influence de cycles hydriques à succion contrôlée (a) et agressifs (b) sur la variation volumique de l'argile d'Héricourt traitée pour différents temps de cure.

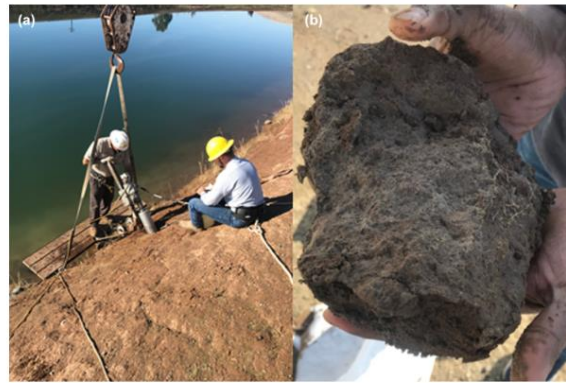
Figure I.33. Campagne de prélèvement du sol dans les sections du canal traitées à la chaux (a), échantillon traité à la chaux (b) (Akula et al., 2020).

et al., 2012). Gutschick (1978) a rapporté qu'aucun glissement connu ne s'est produit dans les sections traitées à la chaux et que la résistance des sols traités a continué d'augmenter avec le temps, même après une immersion prolongée. Plus récemment, Akula et al. (2020) ont étudié le comportement à long terme du sol traité provenant du canal à partir de prélèvement effectué par carottage horizontal (Figure I.33). Une première série d'essai portant sur les caractéristiques géotechniques du sol a tout d'abord été effectuée. Les résultats montrent une baisse de la résistance à la compression non confinée du sol qui était de 965 kPa lors du prélèvement alors qu'elle était mesurée à 3450 kPa, 1 an après la construction. Ces résultats sont cependant peu significatifs : la structure du sol n'a pas pu être conservée lors du prélèvement dans le canal et des éprouvettes restructurées ont été préparées pour obtenir ces résultats.

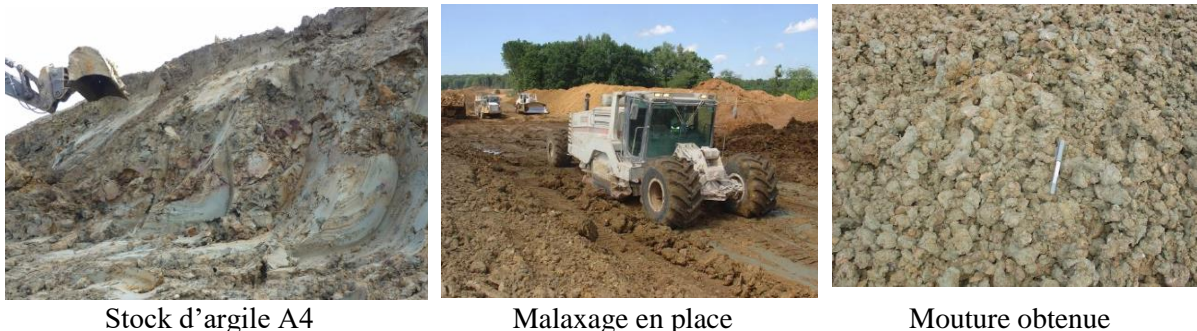
Figure II.2. Prélèvement de l'argile en juillet 2009 (Froumentin, 2012).

Le remblai a été construit en deux parties, la première avec une argile et l'autre avec un limon. Ces deux matériaux ont été prélevés dans la purge de la section courante de la chaussée. Cette étude se concentre uniquement sur la partie du remblai réalisée avec l'argile d'Héricourt (Figure II.2). Le matériau expansif a subi en place plusieurs passages de malaxeur Raco 550 afin d'obtenir une mouture de l'ordre de 0/50 mm.

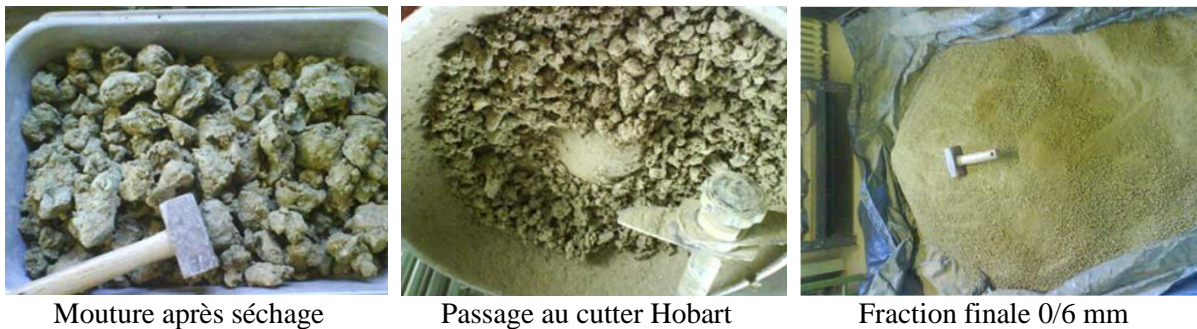
Figure II.4. Préparation de l'argile avant essais de laboratoire (Froumentin, 2012).

L'objectif de la préparation des matériaux était d'obtenir une mouture homogène de 0/6mm (Figure II.4). Dans un premier temps, les mottes argileuses ont été fractionnées manuellement au couteau, puis réparties sur une bâche et séchées à l'air libre pendant 2 j (Froumentin, 2012). Elles ont ensuite été mises dans des bacs puis placées en étuve afin d'être séchées à une température ne dépassant pas 50°C. Les moutures séchées ont été alternativement fractionnées au cutter Hobart © puis passées au tamis de 6 mm. Le refus au tamis de 6 mm est repassé au cutter. Les éléments de type graves et galets supérieurs à 6 mm n'ont pas été incorporés dans les matériaux à traiter. Les matériaux ont été homogénéisés puis remis en sacs de 25 kg à une teneur en eau d'environ 14%.

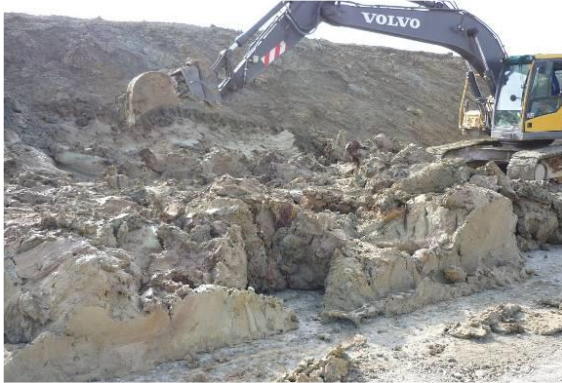
Mise en couche de l'argile avant traitement

Figure II.8. Vues de l'atelier de traitement sur chantier (Froumentin, 2012).

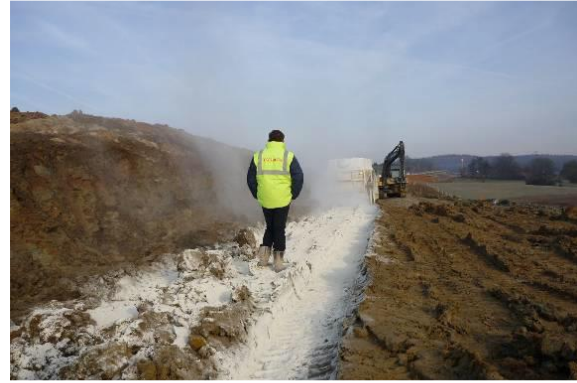
Épandage de la chaux sur l'argile

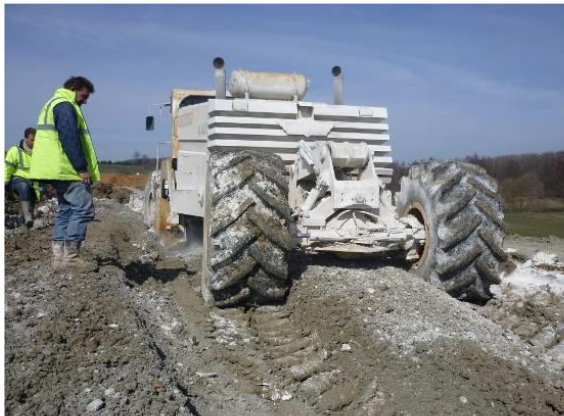
Malaxage de l'argile traitée à la chaux

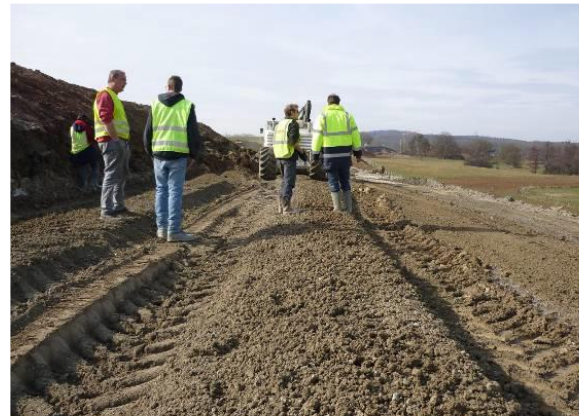
Mouture obtenue en fin de traitement

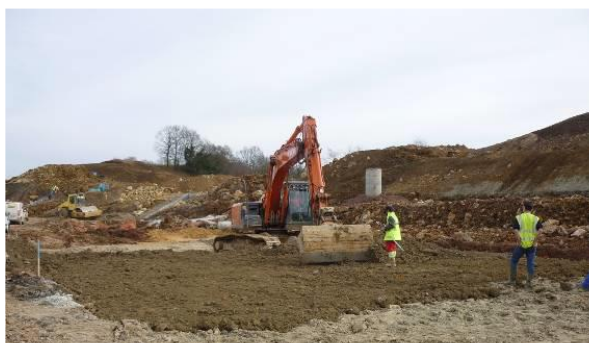
Mise en œuvre du matériau traité

Figure II.9. Compactage des couches de remblai (Froumentin, 2012).

La mise en œuvre sur le site a été effectuée à l'aide d'une pelle équipée d'un godet de curage, et un réglage laser a été utilisé pour assurer une épaisseur de couche conforme à la spécification requise (Figure II.9).

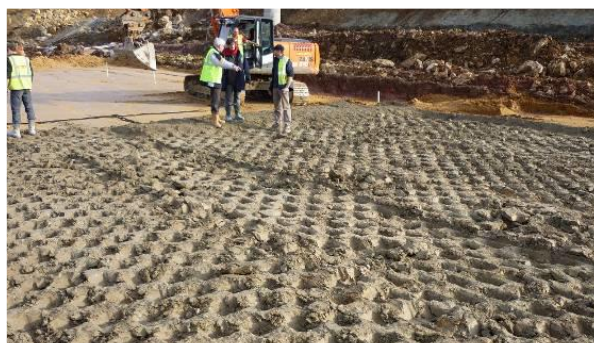
Couche de remblai après compactage au VP5

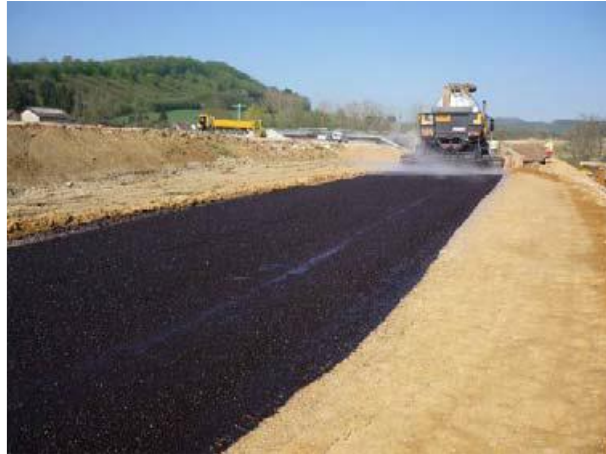
Figure II.10. Seconde couche d'émulsion sur l'assise du remblai (Froumentin, 2012).

Différents ateliers ont été effectués après la mise en place du corps du remblai. Afin d'imperméabiliser la partie supérieure du remblai, la couche d'assise a tout d'abord été revêtue d'un enduit bicouche (Figure II.10).

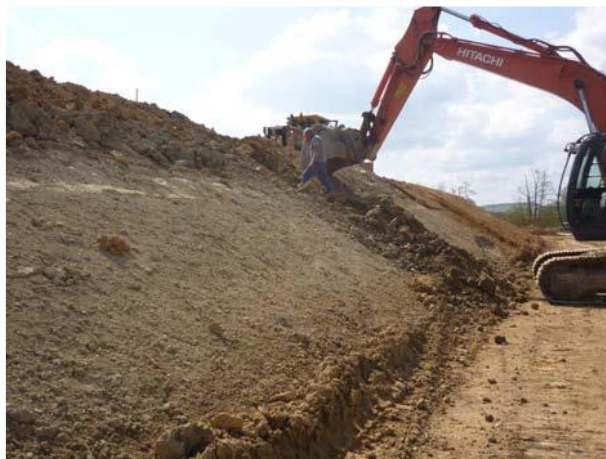
Figure II.11. Retaillage des talus selon la méthode excédentaire (Froumentin, 2012).

Il a été choisi de construire le remblai suivant la méthode excédentaire avec une largeur de 1 m par rapport à la côte horizontale du talus fini. Cette largeur en surplus a ensuite été retaillée à la fin de la construction du remblai (Figure II.11).

Cette méthode permet de garantir les objectifs de compactage, ainsi que l'homogénéité au niveau des bordures de l'ouvrage. Enfin, une couche de terre végétale d'environ 0,10 m a été rajoutée sur le talus à la fin de la construction.

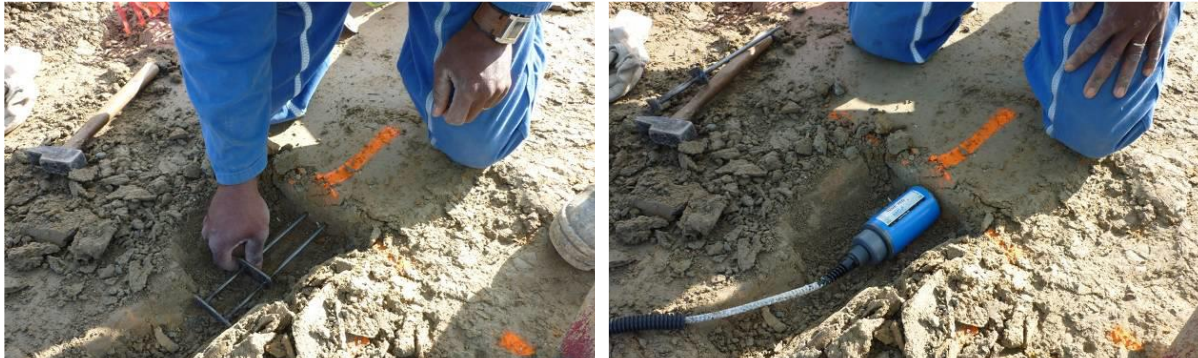
Mise en place du gabarit et perçage des trous

Pose de la sonde

La mesure de la teneur en eau volumique et de la température est réalisée par le même capteur qui est une sonde fonctionnant sur le principe TDR (Time Domain Reflectometry). Dans le sol les sondes sont posées horizontalement (Figure II.14).

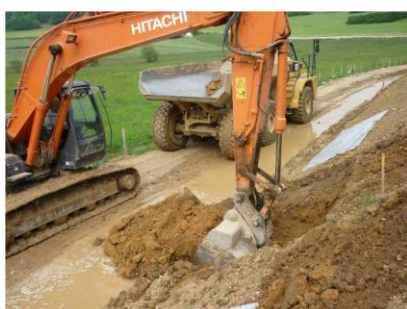
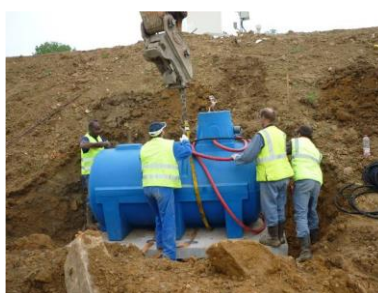
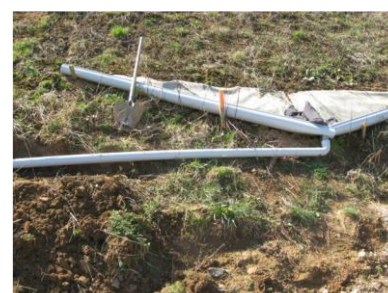
Excavation en pied de remblai pour installation de la cuve

Pose de la cuve sur socle béton

Afin d'évaluer les quantités d'eau qui ruissellent sur les talus, un dispositif constitué d'éléments de gouttières permettant de récupérer les eaux de ruissellement et qui alimentent une cuve enterrée après construction (Figure II.16).

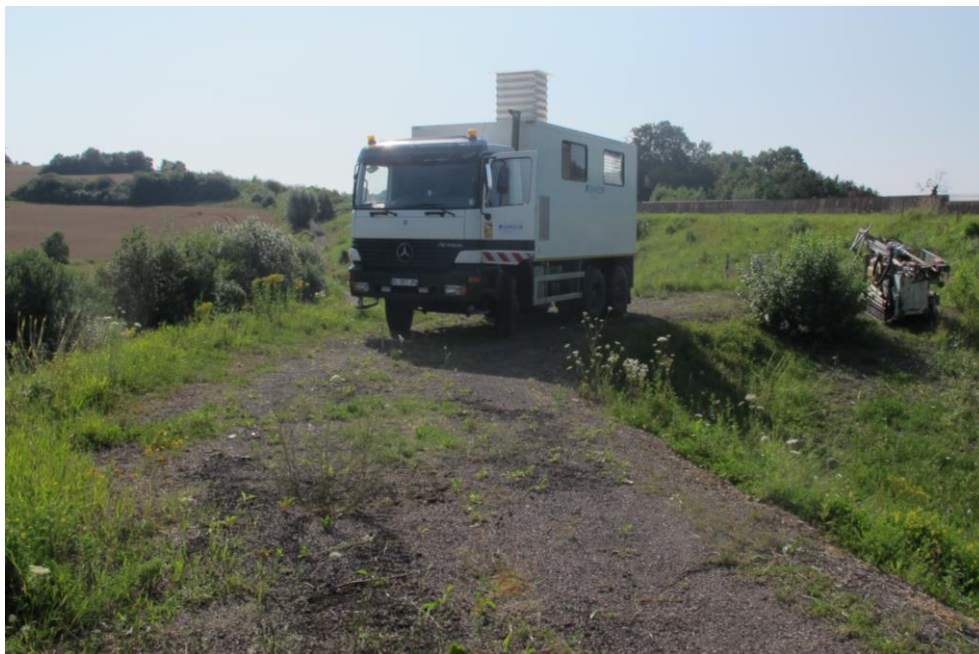
Figure II.23. Sondages CPT-U pendant l'intervention sur le remblai d'Héricourt du 08/2021.

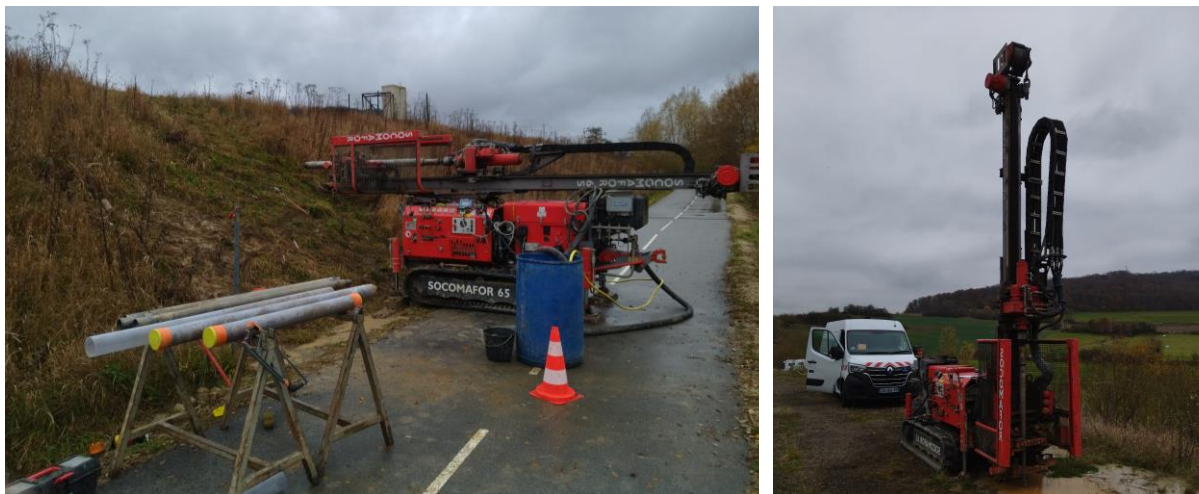
Figure II.28. Carottages horizontaux et verticaux effectués en 11/2023.

Durant la campagne de prélèvement, un carottage horizontal de 4,50 m et un carottage vertical de 6,00 m ont été effectués pour chaque casier (Figure II.28). Les carottes ont ensuite été stockées en laboratoire à une température de 20 ± 5 °C dans des tubes hermétiques d'un diamètre interne de 100 mm et d'une longueur de 1,50 m.

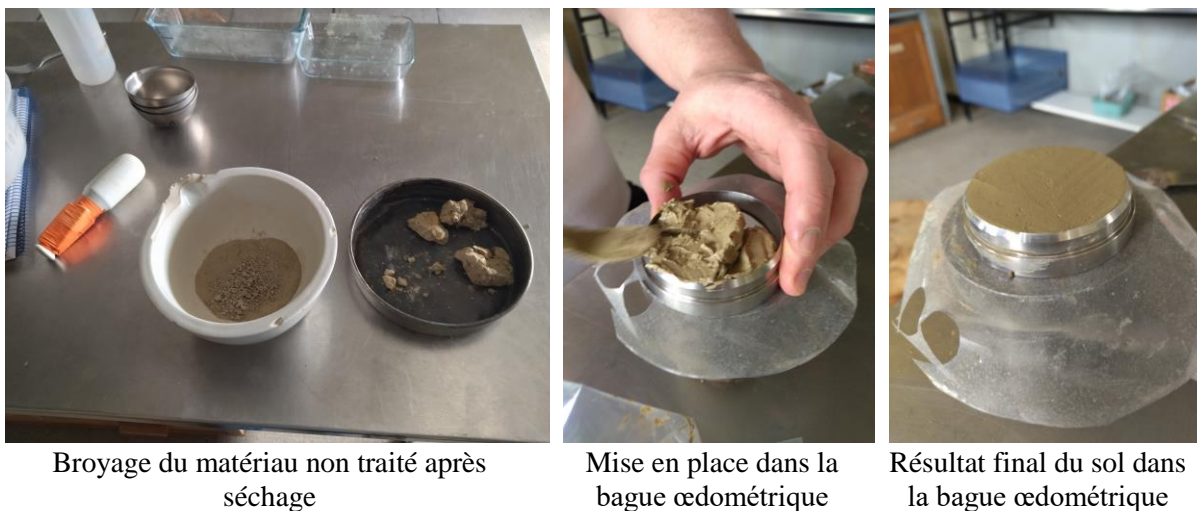
Figure II.30. Préparation du sol non traité afin d'obtenir la courbe vierge du matériau.

Le sol non traité prélevé dans le casier 1 du remblai a été séché à l'étuve, puis broyé finement. Le sol a ensuite été humidifié à la limite de liquidité du matériau, soit 71 %. La pâte de sol ainsi produite a ensuite été insérée délicatement dans une bague œdométrique.

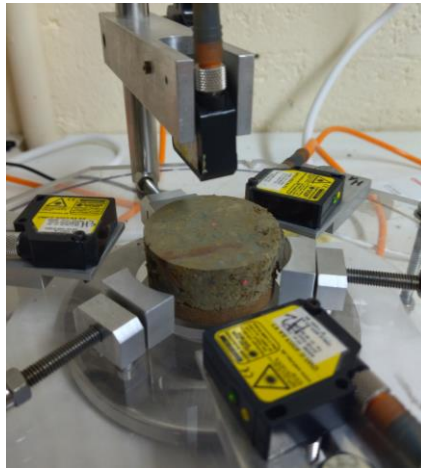
Figure II.31. Essais de retrait adapté de la norme française NF XP P94-060-2 (1997).

Des essais de retrait ont également été réalisés pour évaluer le comportement au retrait des échantillons provenant du remblai, la chaux et le ciment modifiant les caractéristiques de gonflement et de retrait des sols expansifs. Sur chaque section de l'ouvrage, des tests de retrait ont été réalisés dans la partie intérieure (à 0,30 m de la surface) et dans la partie extérieure du remblai (à 6,50 m de la surface). Ces tests ont été préparés de manière similaire aux échantillons d'œdomètre. Le test de retrait est adapté de la norme française NF XP P94-060-2 (1997) en

remplaçant les capteurs de déplacement conventionnels par des capteurs laser pour mesurer à distance les retraits (Figure II.31).

Cette modification a considérablement réduit l'impact du dispositif de mesure sur l'enregistrement du retrait du sol. Pendant le processus de séchage, la masse du sol et sa variation de volume ont été enregistrées. Lors de la stabilisation de la masse, l'éprouvette a été placée en étuve pour déterminer sa teneur en eau.

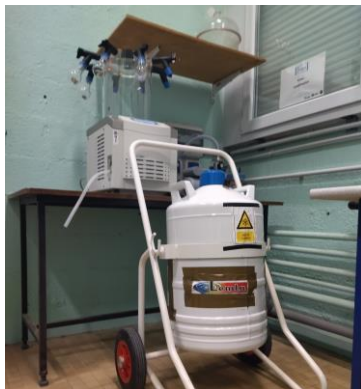
Azote liquide utilisée pour la préparation des cubes de sol

Figure II.32 Préparation des cubes de sol pour les essais MIP et les observations au MEB.

Pour l'étude microstructurale du sol, une méthode de préparation spécifique a été choisie. Les spécimens ont été façonnés en cubes avec des dimensions approximatives de 10 mm de côté. Les échantillons ont ensuite été soumis à un processus de lyophilisation en les plongeant dans de l'azote liquide à une température de -196°C . Ils ont été placés dans une chambre à vide afin d'enlever l'eau du sol par sublimation (Figure II.32). Ce protocole limite l'impact du séchage sur la microstructure du sol (Cuisinier & Laloui, 2004). Les cubes de sol ont ensuite été conservés dans un contenant hermétique jusqu'à utilisation.

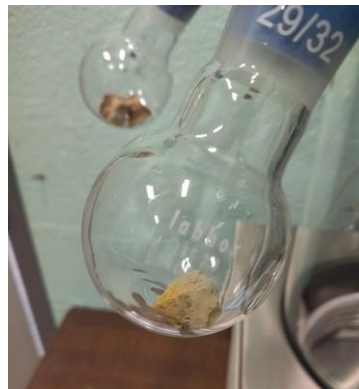
Sublimation de l'eau présente dans les cubes

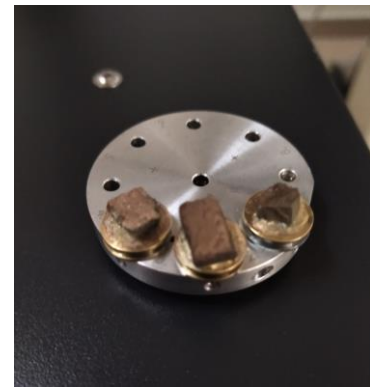
Éprouvettes préparées avant observation au MEB

Avant les observations, un revêtement d'or a été appliqué sur les échantillons sur une surface de fracture fraîche (Figure II.32).

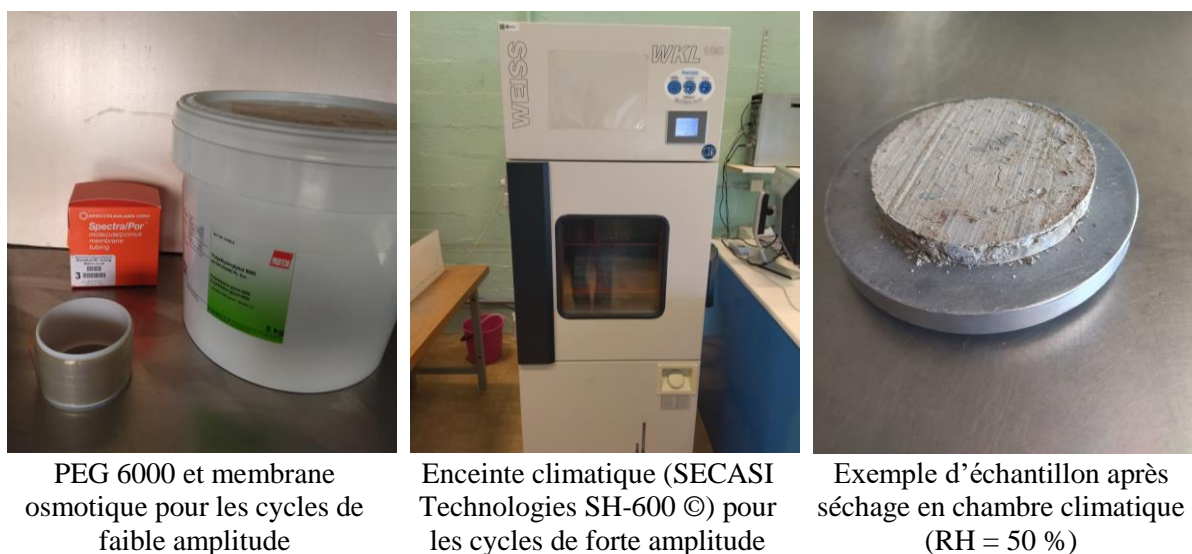
Figure II.34. Matériel nécessaire à la simulation des cycles de séchage et d'humidification.

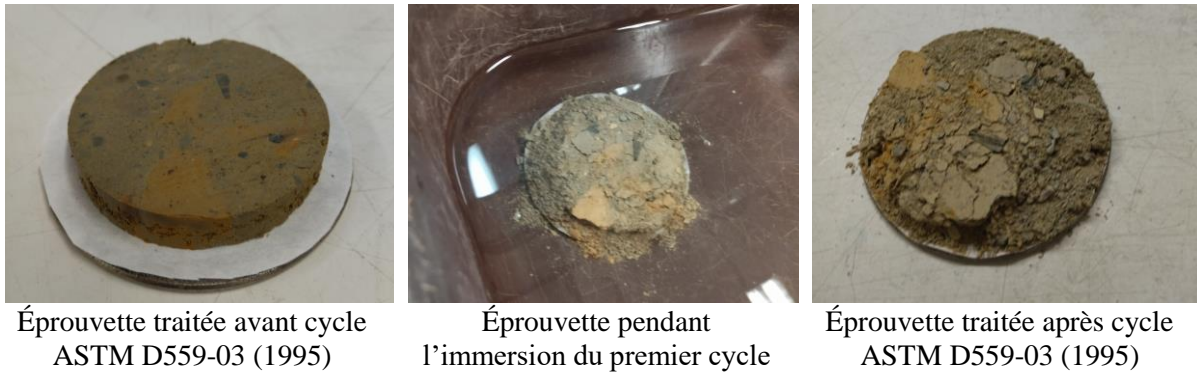
Figure II.35. Éprouvette traitée soumise à un cycle ASTM D559-03 (1995).

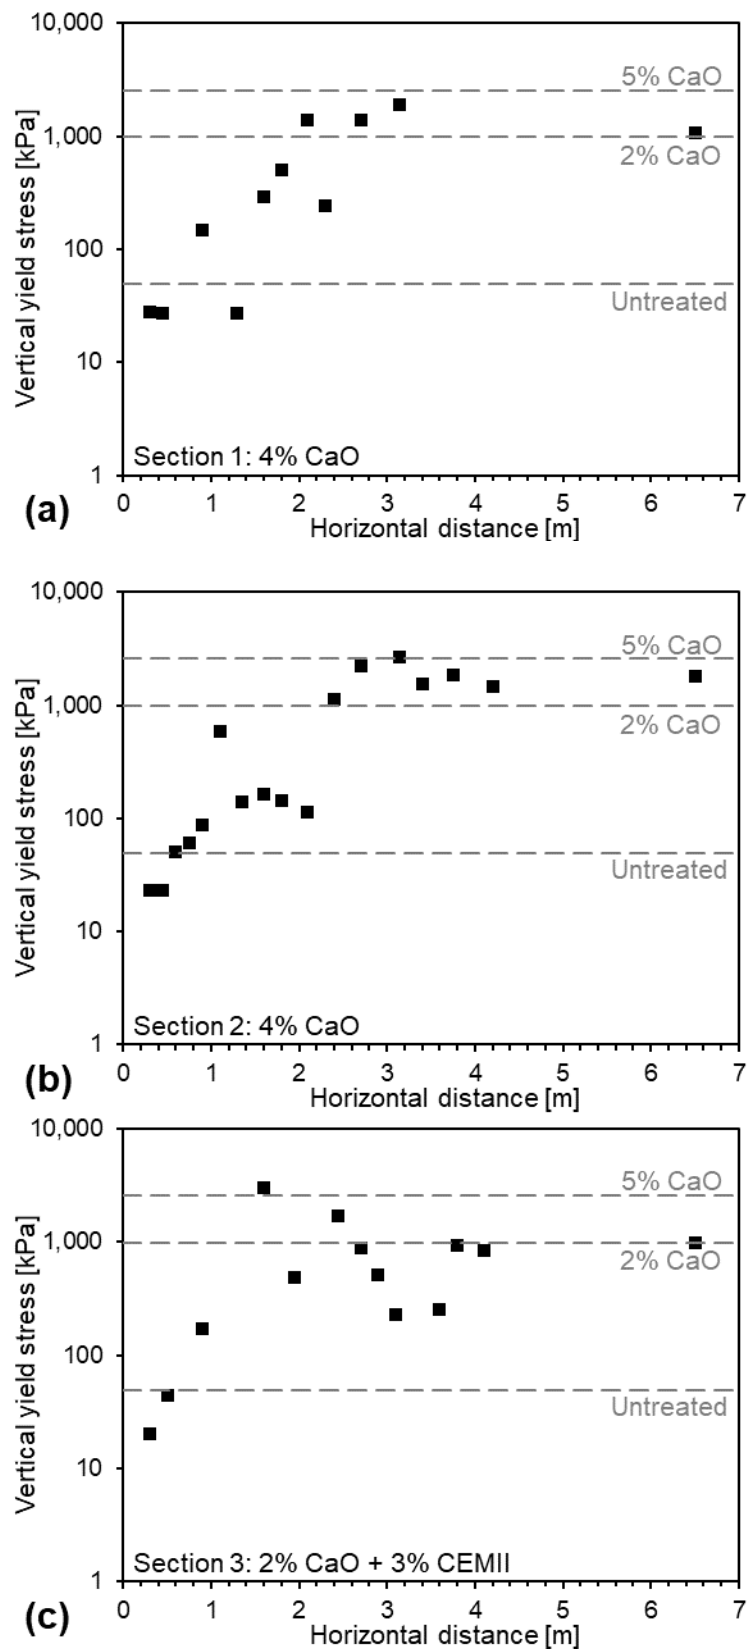
Figure III.5. Yield stress of specimens taken from various horizontal distances of section 1 (a), section 2 (b) and section 3 (c) and compared to the yield stress of the untreated clayey soil, and to the yield stress of specimens treated in laboratory at 2% and 5% lime.

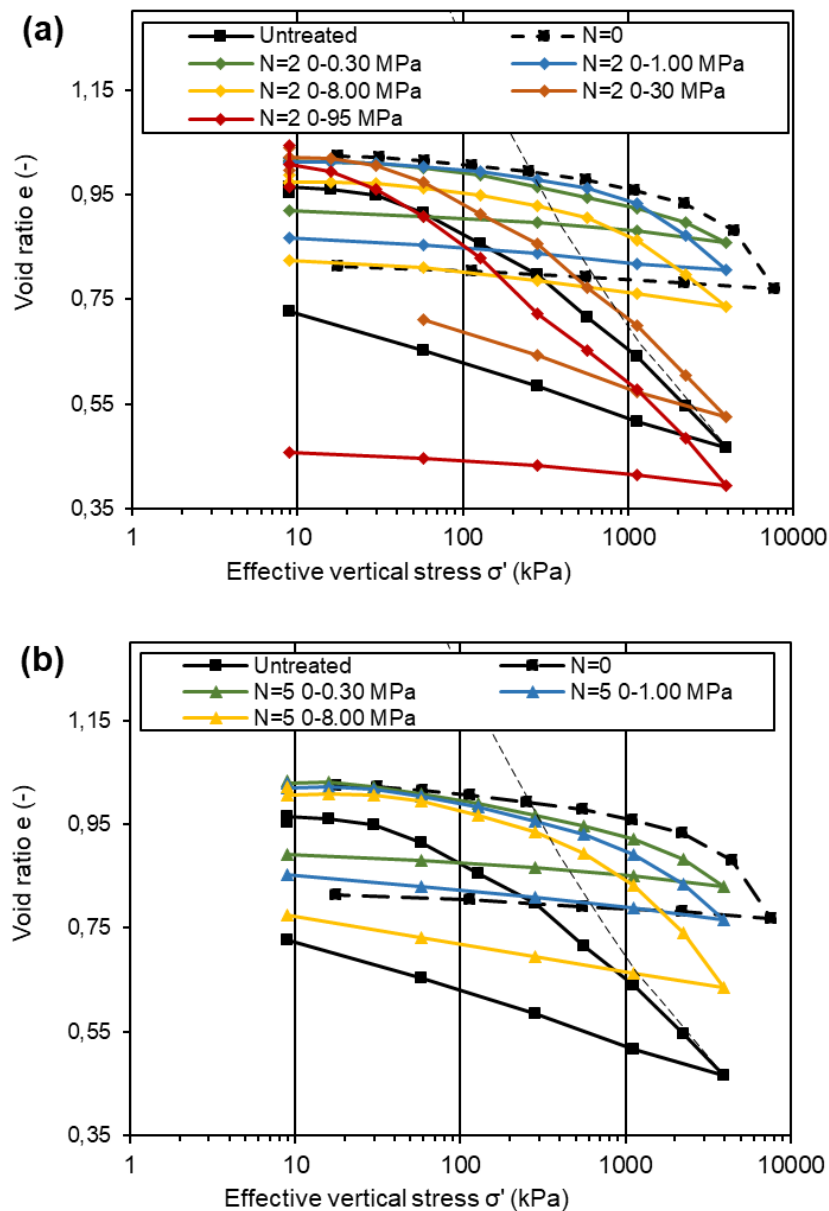
Figure V.2. Compression curve of lime-treated specimens exposed to 2 (a) and 5 (b) wetting and drying cycles with different ranges of suctions compared to the intrinsic compression line (ICL).
